**WEST VIRGINIA DEPARTMENT OF ENVIRONMENTAL PROTECTION  
WV/NPDES CONSTRUCTION STORMWATER PERMIT**

<b>FACILITY NAME:</b>	Northport Avenue Extension			<b>REG. #</b>	<b>EXPIRE DATE:</b>
<b>PERMITTEE</b>	RANSON, CITY OF			WVR110191	9/2/2020
<b>ADDRESS/PHONE:</b>	Attn: ANDREW P. BLAKE, CITY MGR 312 SO MILDRED ST RANSON, WV 25438 3047251010				
<b>LOCATION:</b>	39 22 12.95 N77 52 32.83 W			<b>Entry Date/Time:</b>	2/6/2020 @ 1103
<b>COUNTY:</b>	Jefferson			<b>Exit Date/Time:</b>	2/6/2020 @ 1224
<b>Site Representative /Phone</b>				<b>PHOTOS</b> <input checked="" type="checkbox"/>	
<b>CO-PERMITTEE:</b>				<b>ADDRESS:</b>	
<b>SITE OPERATOR:</b>				<b>ADDRESS:</b>	
<b>PERMITTED ACREAGE</b>	24.4	<b>WEATHER:</b>	Rain	<b>LAST INSPECTION:</b>	N/A
<b>RECEIVING STREAM(S)</b>	Rockymarsh				<b>NOV:</b> <b>W20-19-012-TDH</b>
<b>Regular Mail</b> <input type="checkbox"/> <b>Certified Mail</b> <input checked="" type="checkbox"/>		<b>Tracking #</b> 70192970000166130895			
<b>OVERALL FACILITY RATING:</b>	<b>Unsatisfactory</b>		<b>COMPLIANCE OUTCOME</b>	<b>Not Immediately Corrected</b>

STATE OF WEST VIRGINIA  
Department of Environmental Protection  
Environmental Enforcement  
NOTICE OF VIOLATION

Viol

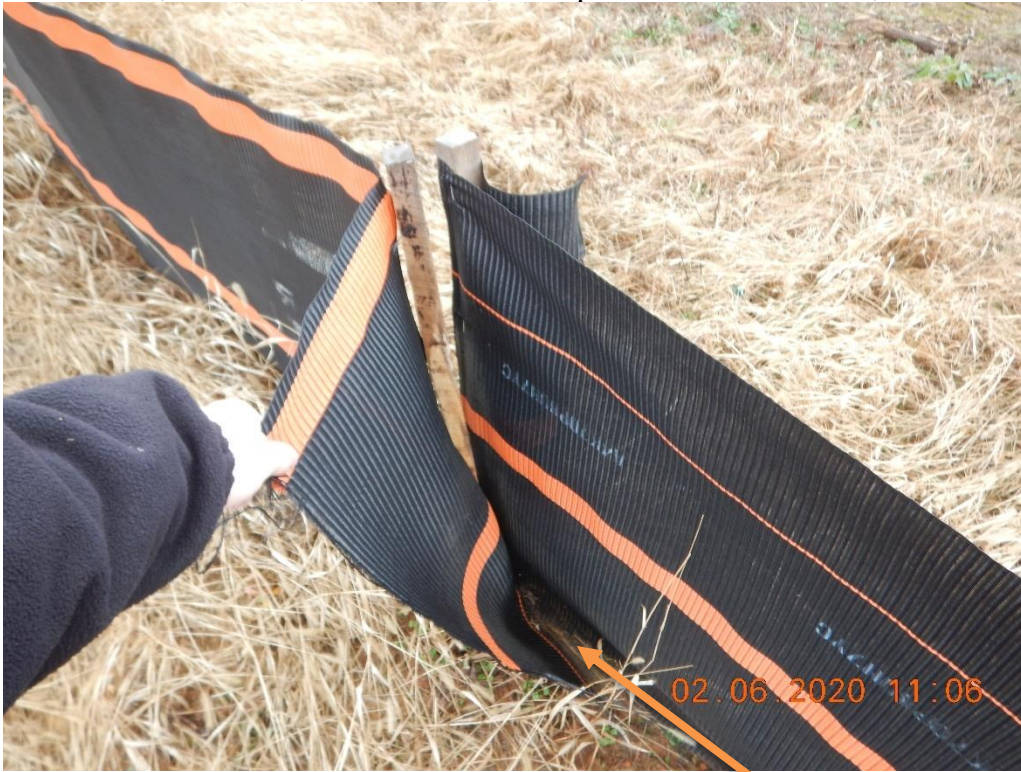
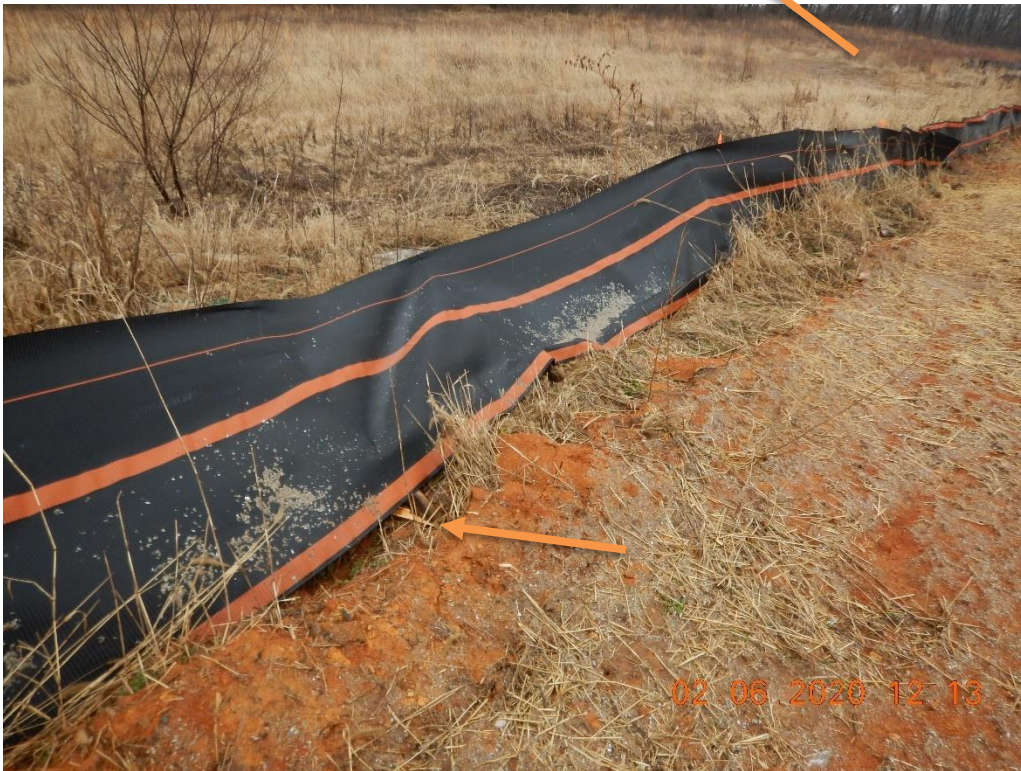
6. **Section G.4.e.2.- City of Ranson failed to properly implement controls. Perimeter controls are not properly installed, there are many areas where the toe of the silt fence was not toed in correctly and many panels of silt fence was not conjoined correctly as indicated in the plan details on sheet 19.**

Perimeter controls are not properly installed, there are many areas where the toe of the silt fence was not toed in correctly and many panels of silt fence was not conjoined correctly as indicated in the plan details on sheet 19.

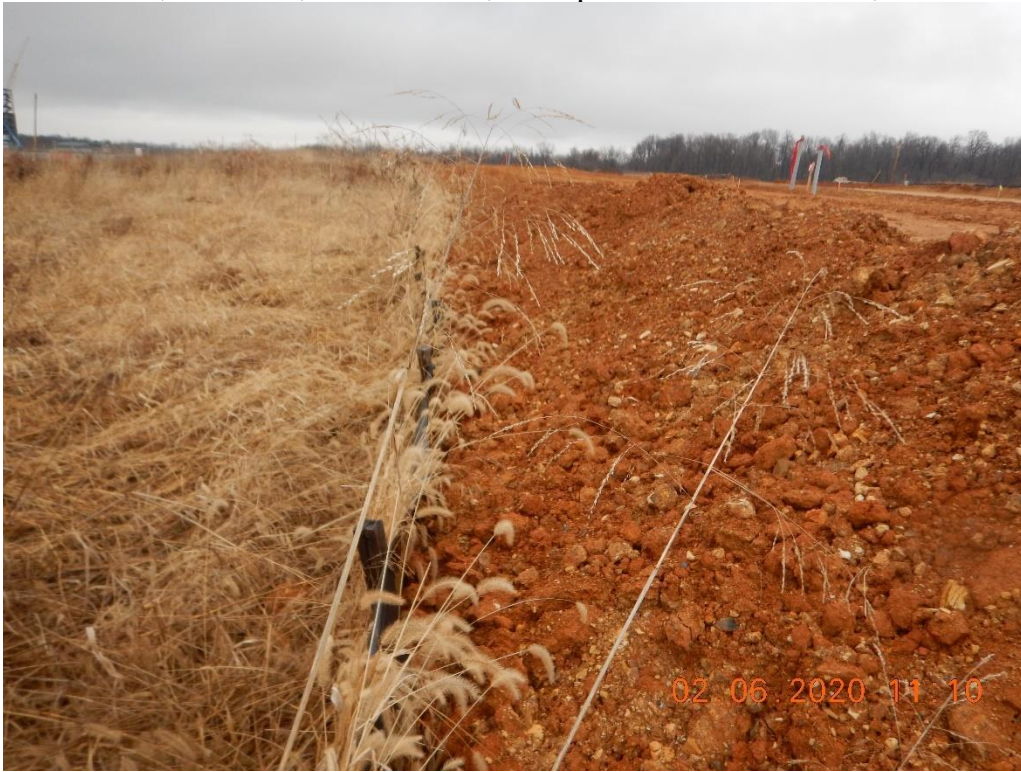
3. **Section D.1.- City of Ranson failed to operate and maintain all erosion control devices. Where soil is being pushed up against silt fence, there is no holding complicity to allow proper filtration before controls are overtopped. Rock aprons are showing wear around a few drop inlets. Some sections of silt fence are down, and need maintained throughout site.**

Where soil is being pushed up against silt fence, there is no holding capacity to allow proper filtration before being overtopped.

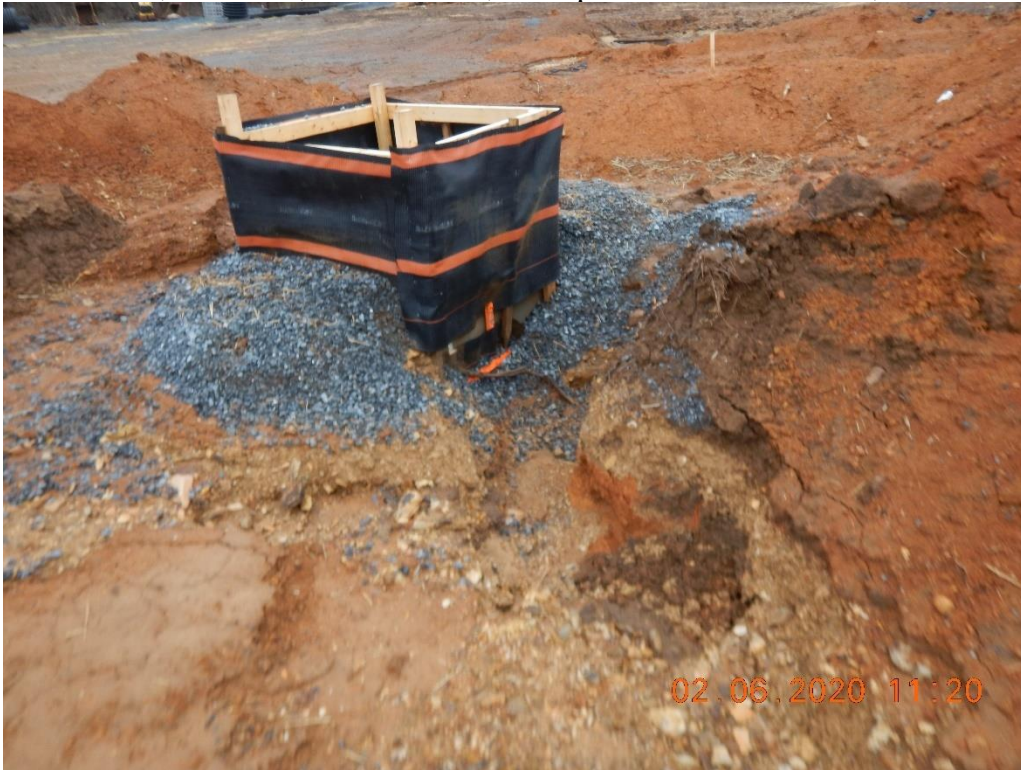
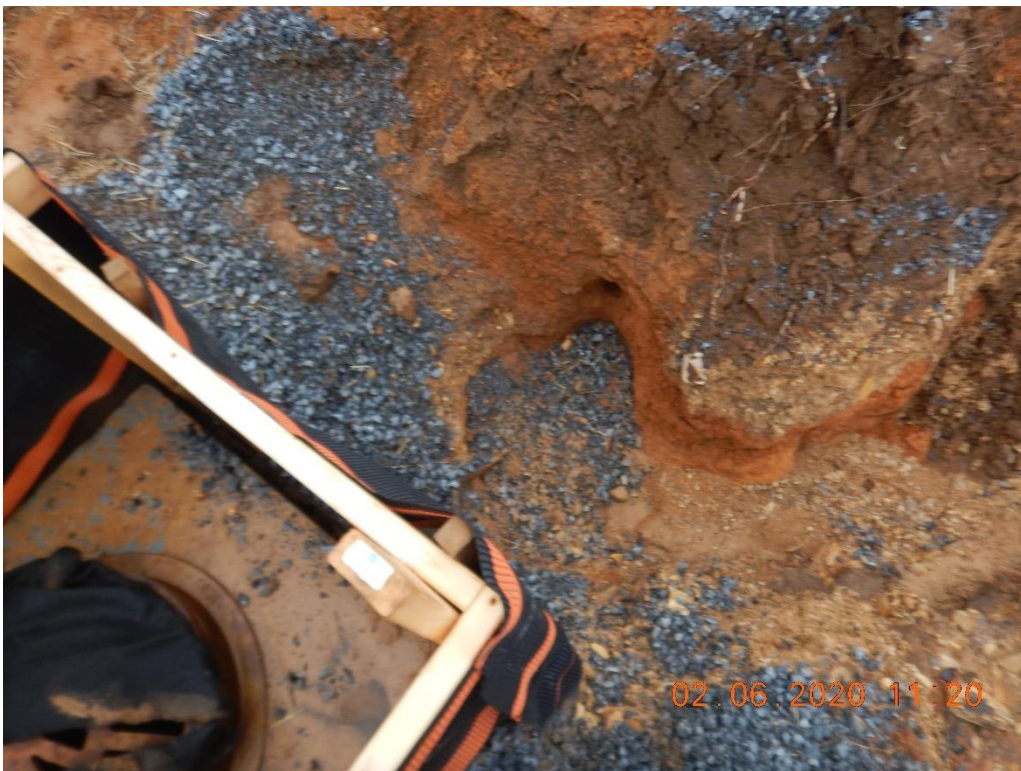
Maintenance on Drop Inlet protection where rock apron has been eroded away.

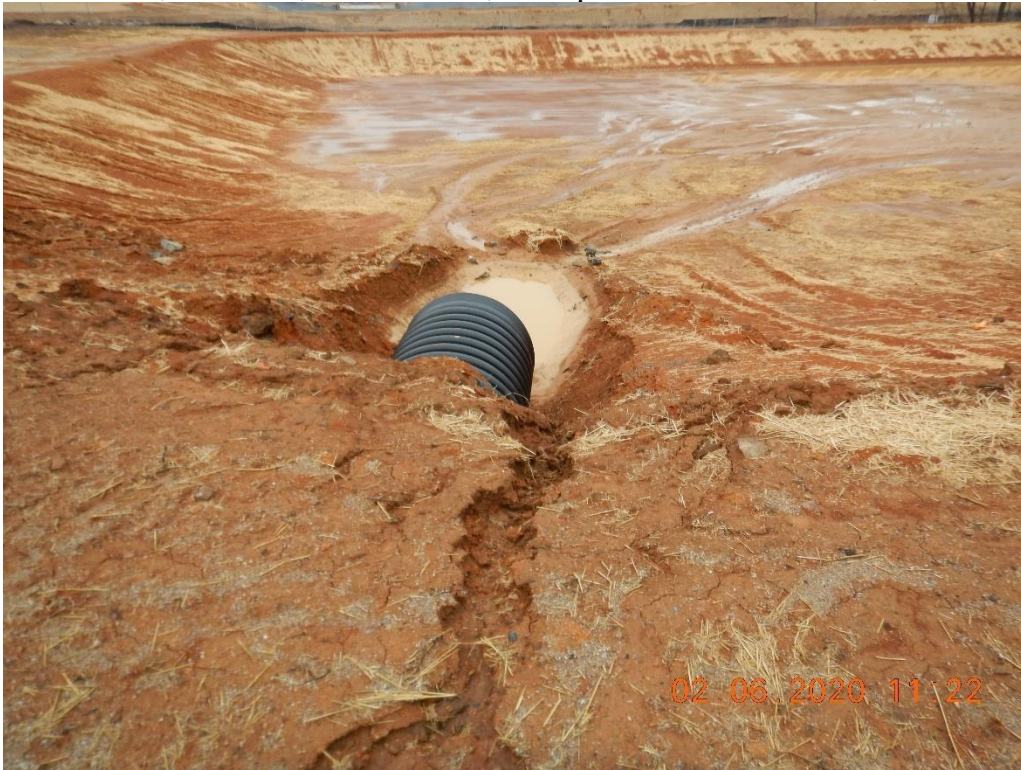
9. Section G.4.e.2.A.ii.c.: City of Ranson failed to provide inlet protection for sediment control structure. No inlet protection was provided in Sediment Basin.

Unprotected Inlet into sediment basin.

1. Provide proper inlet protection.
2. Document and maintain onsite all inspections of erosion control devices and maintenance activities.
3. Operate and maintain all erosion control devices to achieve compliance with the permit.

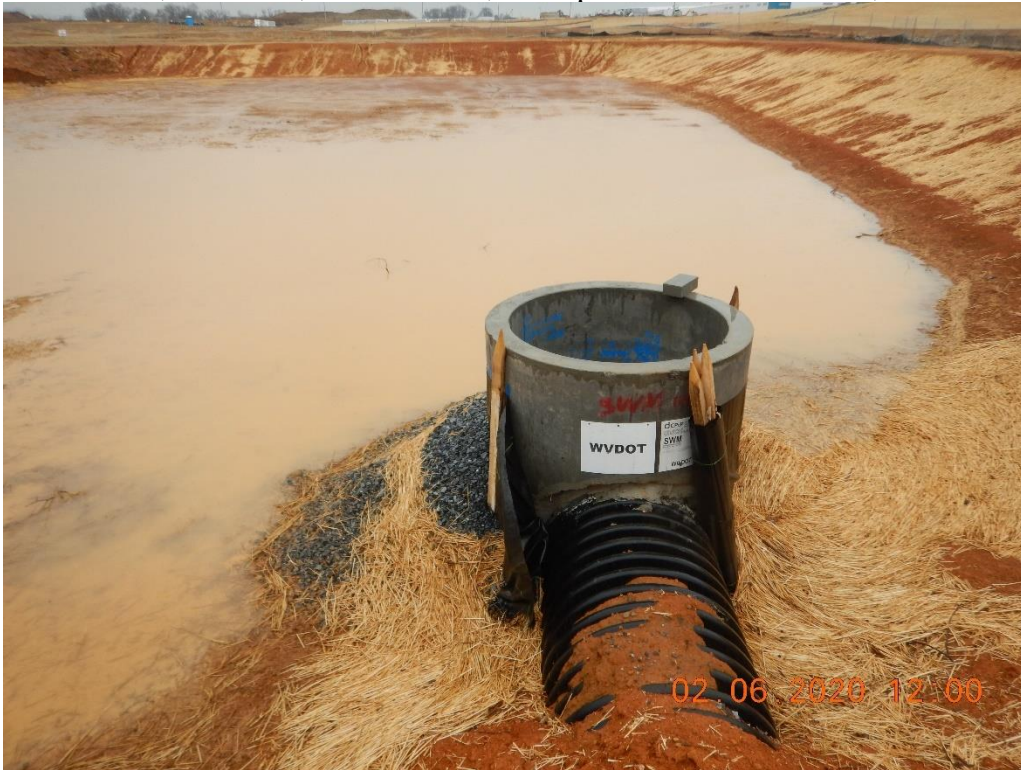
8. Section G.4.e.2.A.ii.b.: City of Ranson failed to properly operate sediment basin. Sediment basin is not being operated correctly and is allowing sediment laden water to leave the site without going through an appropriate erosion control device. Sediment basin should be set up to 50% percent wet/dry compacity. At time of inspection it is set up for stormwater retention with the orifices at bottom grade of basin. This is not allowing any settling time for sediment.

Sediment basin is not being operated correctly and is allowing sediment laden water to leave the site without going through an appropriate erosion control device. Sediment basin should be set up to 50% percent wet/dry compacity. At time of inspection it is set up for stormwater retention with the orifices at bottom grade of basin.

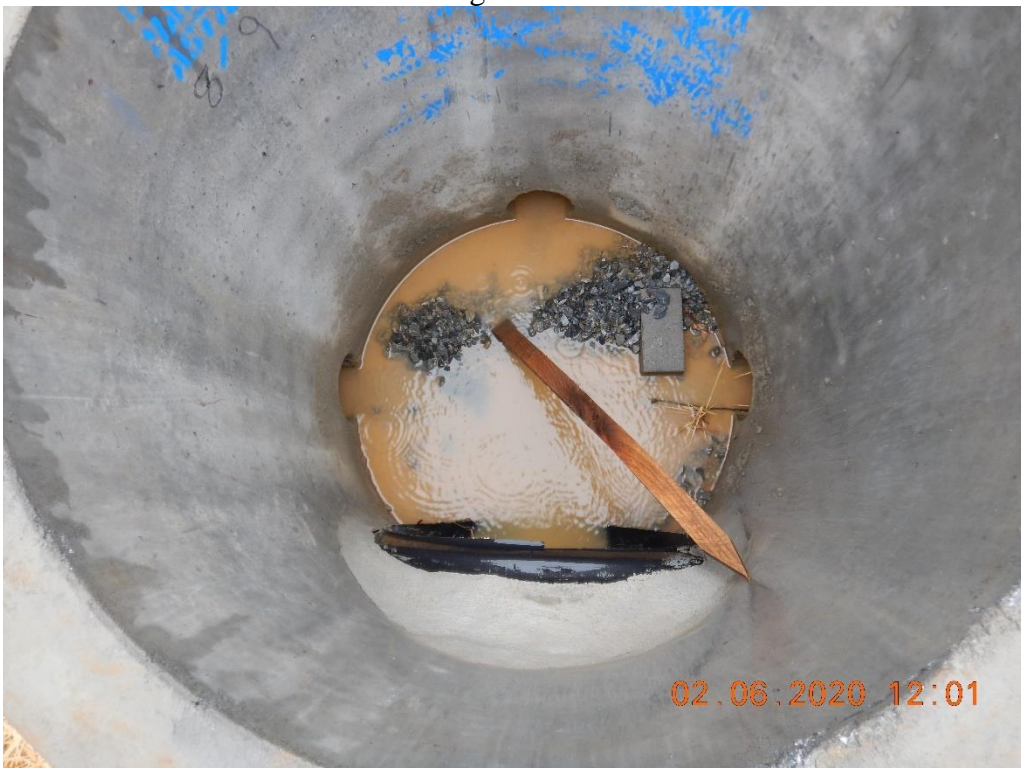
Sediment laden water leaving Sediment Basin through orifice in riser.

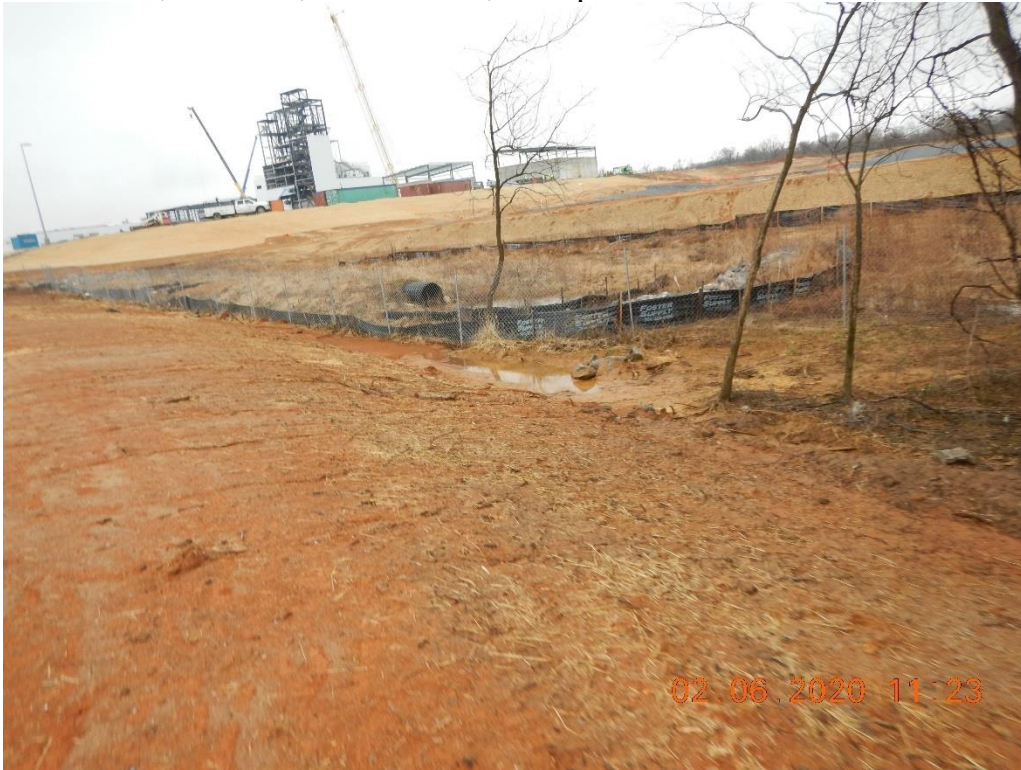
Sediment deposit outside the LOD below Sediment Basin. No perimeter controls installed at this location.

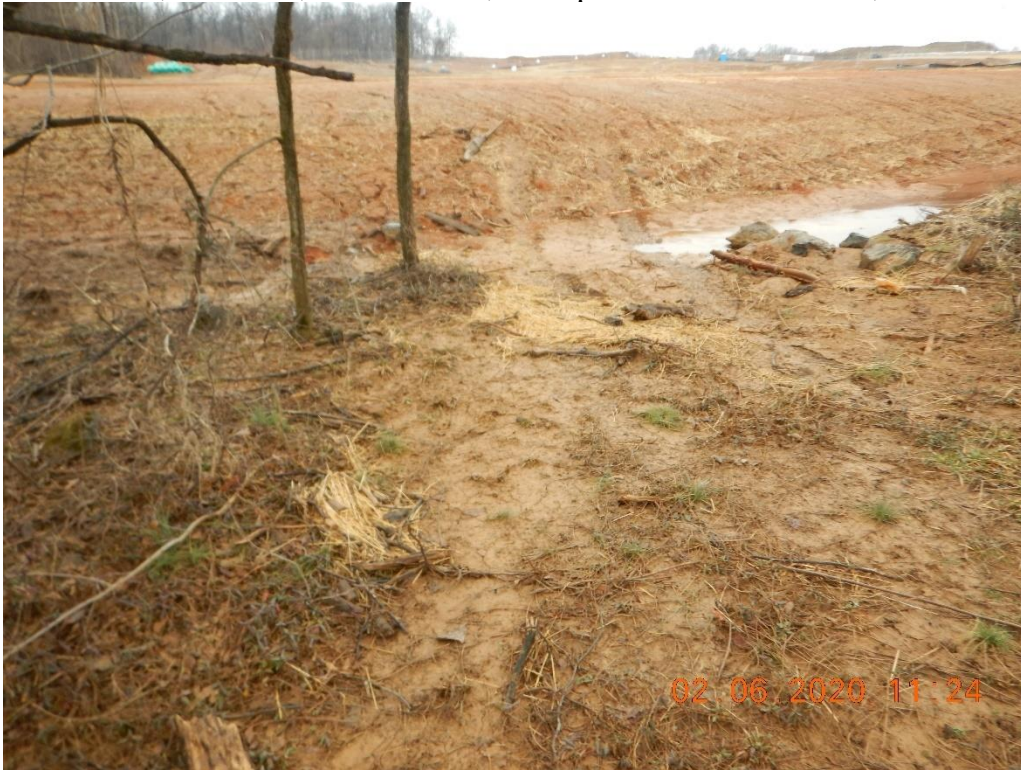
Sediment deposit outside the LOD below Sediment Basin. No perimeter controls installed at this location.

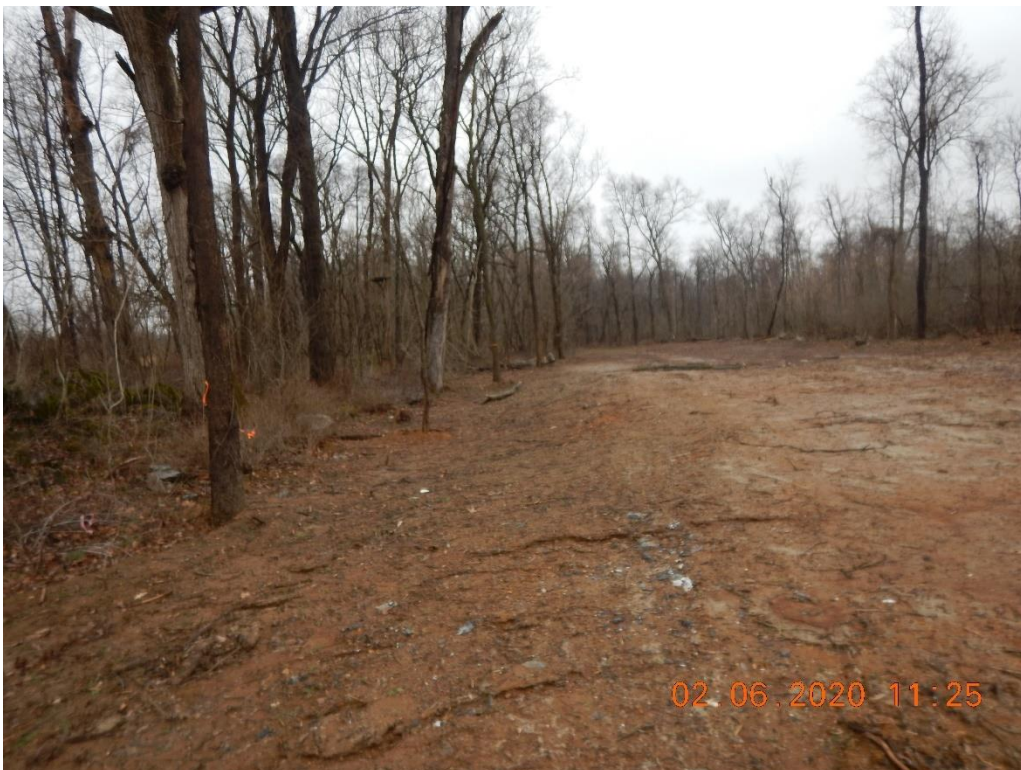
No perimeter controls installed along LOD along collection ditch #1.

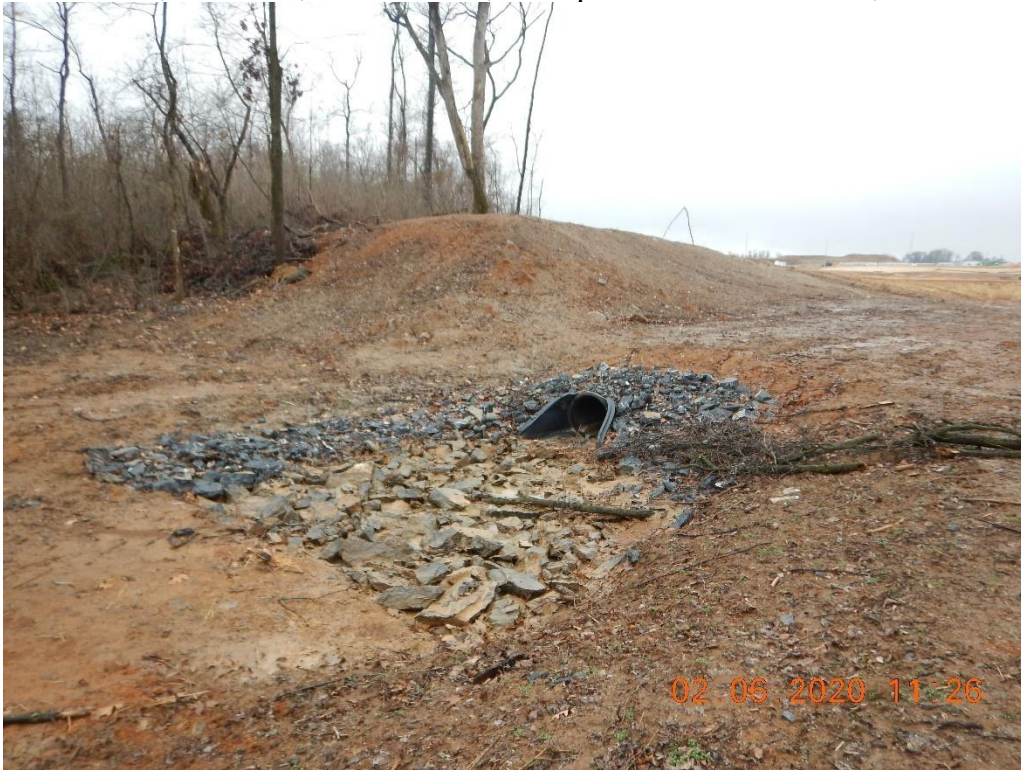
2. **Section C.15.- City of Ranson failed to post an outlet marker at all permitted outlets from the construction site. No outlet signage was posted at the outfall of the sediment basin.**

Outfall of sediment basin with not signage posited. Rip rap apron is stained with sediment from improperly operated basin.

4. Install necessary erosion control devices and modify the SWPPP to prevent sediment- laden water from leaving the site.
5. Display an outlet marker on the stream bank in accordance with Title 47, Series 11, Section 9 of the WV Legislative Rules (Special Rules).

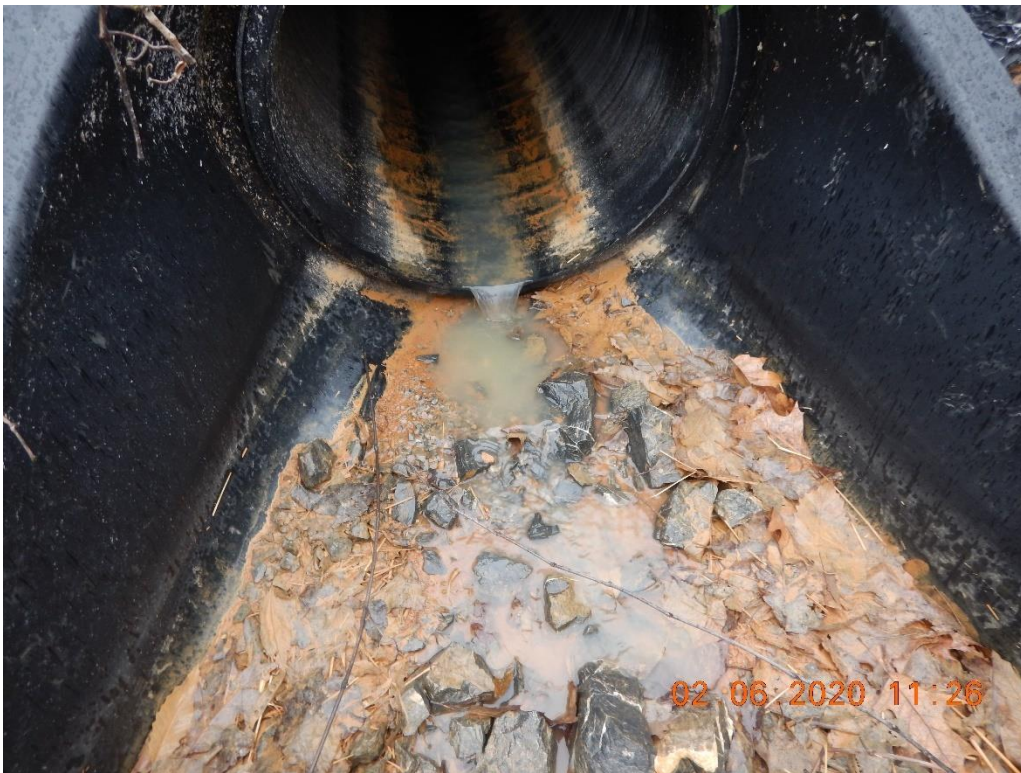
Sediment laden water coming out of sediment basin outfall.

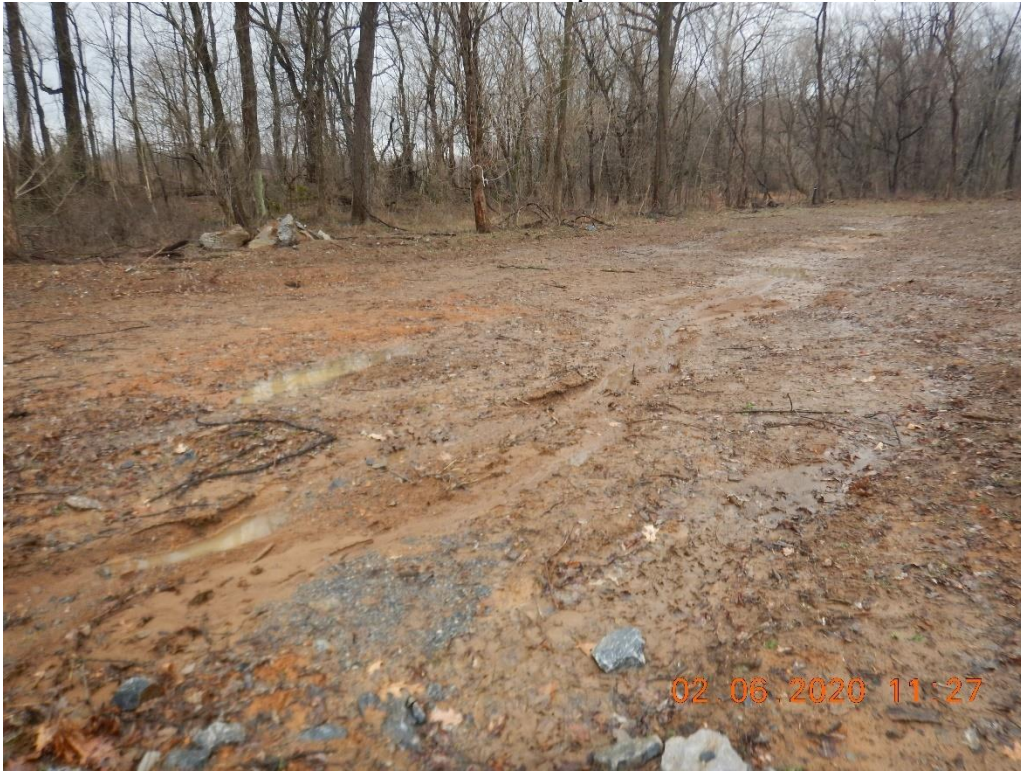
Diversion channel #1 from sediment basin outlet not installed.

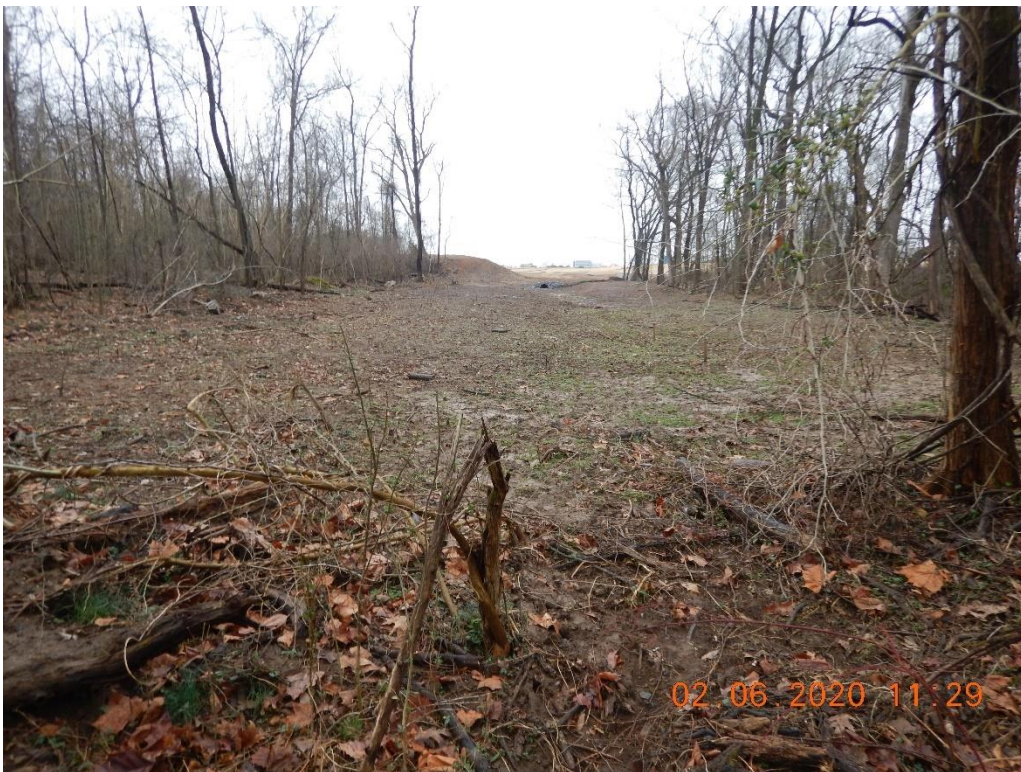
Diversion channel #1 and rip rap apron #2 not installed at time of inspection.

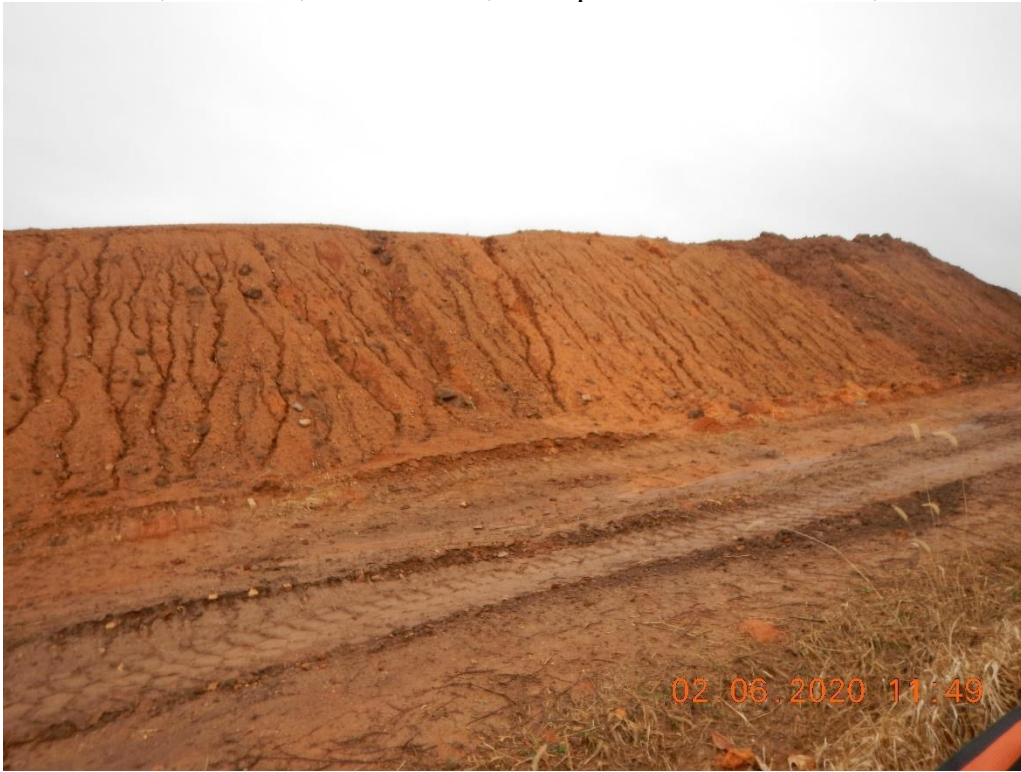
7. Section G.4.e.2.A.i.- City of Ranson failed to provide interim stabilization on areas where construction activities have temporarily ceased for more than 14 days. Soil stockpile and other constructed slopes are not temporary stabilize that have set idle for more than 14 days.

Soil stockpiles are not temporary stabilized with erosion rills.

9. Seed and mulch all areas where construction activities have ceased for more than 14 days.
10. Provide adequate stone at the entrance/exit of the access road.

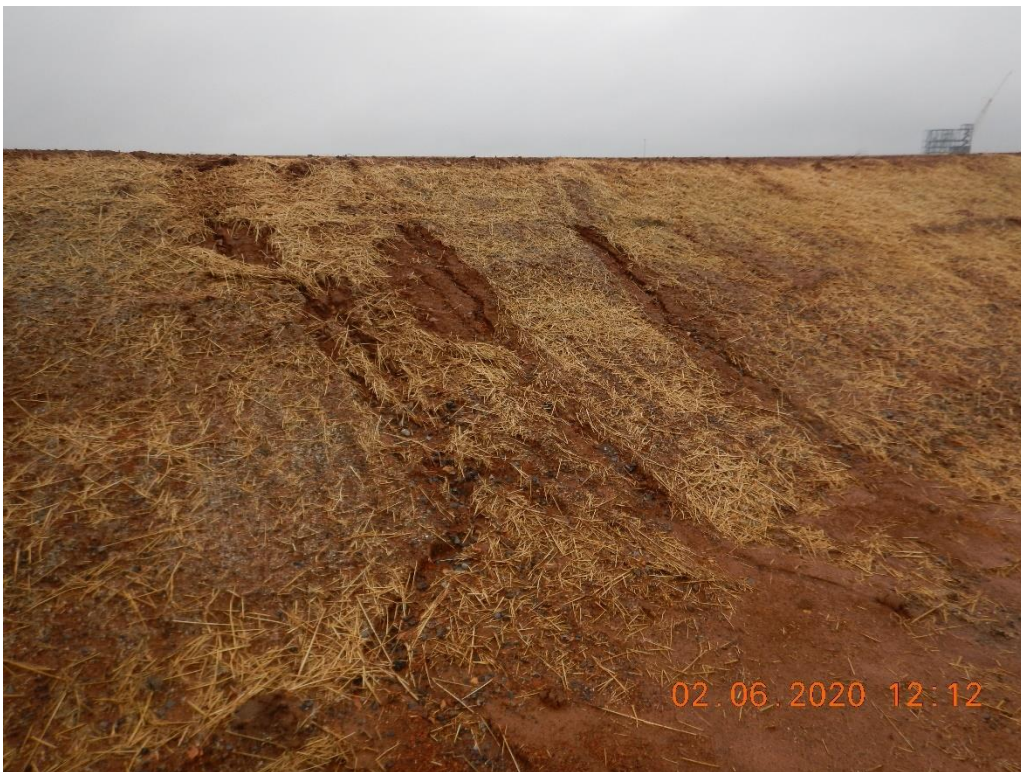
10. Section G.4.e.2.A.ii.f.- City of Ranson failed to protect fill slopes. Improperly tracked in constructed slopes are aiding to the development of erosion rills that are forming on fill slopes throughout the project site.

Improperly tracked in constructed slopes are aiding in the development of erosion rills to form on fill slopes that are found throughout the project site.

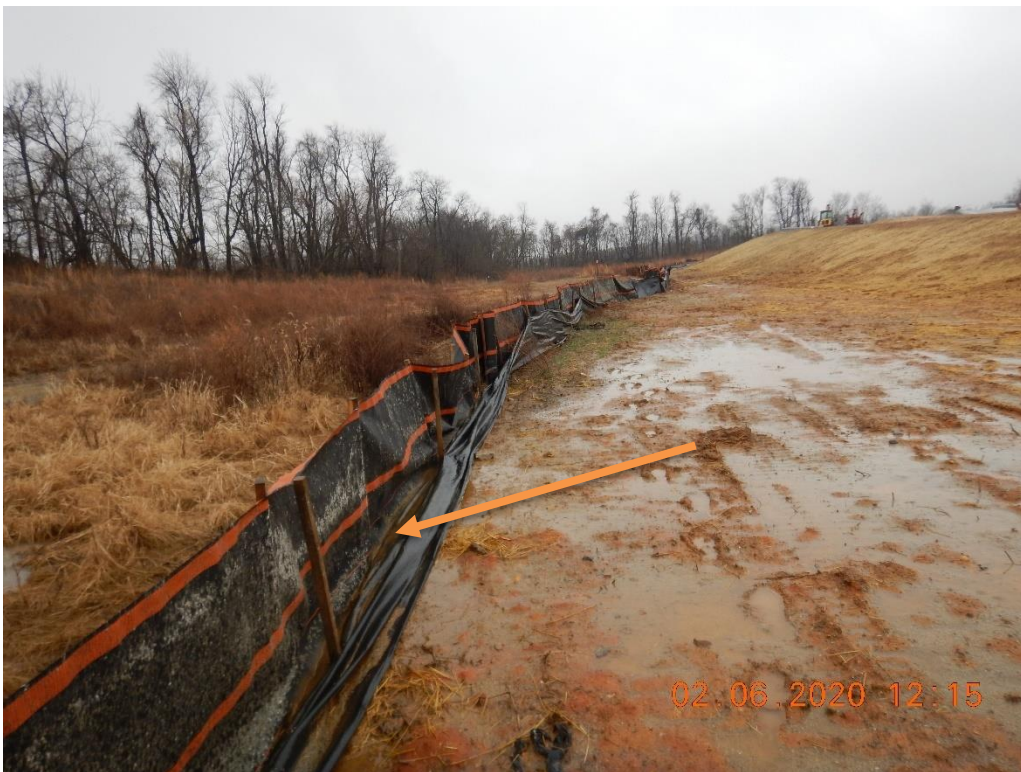
By-pass under silt fence that allows sediment laden water to leave the site.

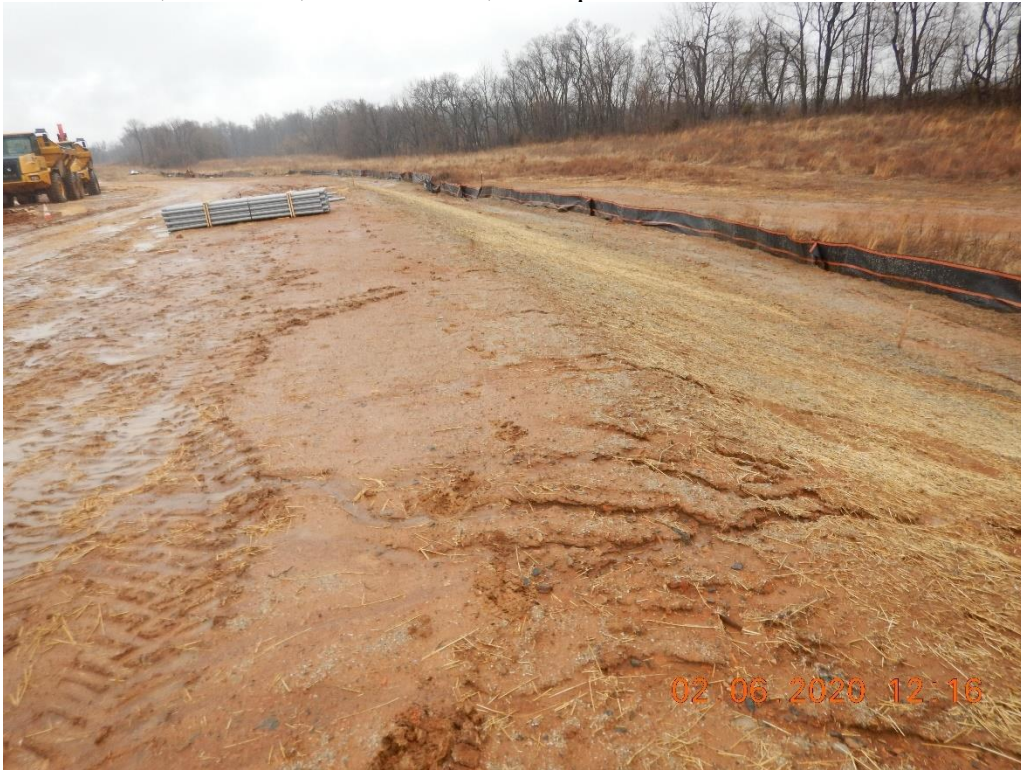
No fill slope protection on constructed slopes with erosion rills.
