**WEST VIRGINIA DEPARTMENT OF ENVIRONMENTAL PROTECTION  
WV/NPDES CONSTRUCTION STORMWATER PERMIT**

<b>FACILITY NAME:</b>	Northport Avenue Extension			<b>REG. #</b>	<b>EXPIRE DATE:</b>
<b>PERMITTEE</b>	RANSON, CITY OF			WVR110191	9/2/2020
<b>ADDRESS/PHONE:</b>	Attn: ANDREW P. BLAKE, CITY MGR 312 SO MILDRED ST RANSON, WV 25438 3047251010				
<b>LOCATION:</b>	39 22 12.95 N77 52 32.83 W			<b>Entry Date/Time:</b>	2/6/2020 @ 1103
<b>COUNTY:</b>	Jefferson			<b>Exit Date/Time:</b>	2/6/2020 @ 1224
<b>Site Representative /Phone</b>				<b>PHOTOS</b> <input checked="" type="checkbox"/>	
<b>CO-PERMITTEE:</b>				<b>ADDRESS:</b>	
<b>SITE OPERATOR:</b>				<b>ADDRESS:</b>	
<b>PERMITTED ACREAGE</b>	24.4	<b>WEATHER:</b>	Rain	<b>LAST INSPECTION:</b>	N/A
<b>RECEIVING STREAM(S)</b>	Rockymarsh				<b>NOV:</b> <b>W20-19-012-TDH</b>
<b>Regular Mail</b> <input type="checkbox"/> <b>Certified Mail</b> <input checked="" type="checkbox"/>		<b>Tracking #</b> 70192970000166130895			
<b>OVERALL FACILITY RATING:</b>	<b>Unsatisfactory</b>		<b>COMPLIANCE OUTCOME</b>	<b>Not Immediately Corrected</b>

STATE OF WEST VIRGINIA  
Department of Environmental Protection  
Environmental Enforcement  
NOTICE OF VIOLATION

Faci

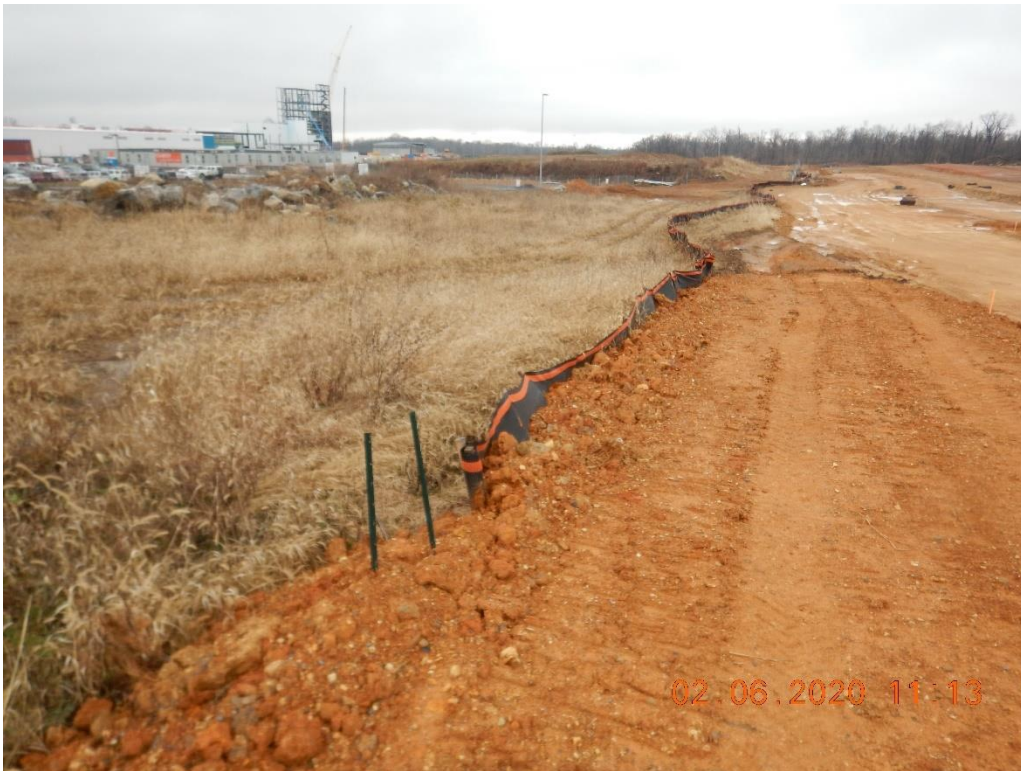
5. (6) Where soil is being pushed up against silt fence, there is no holding capacity to allow proper filtration before controls are overtopped. Rock aprons are showing wear around a few drop inlets. Some sections of silt fence are down, and need maintained throughout site.

3. **Section D.1.- City of Ranson failed to operate and maintain all erosion control devices. Where soil is being pushed up against silt fence, there is no holding complicity to allow proper filtration before controls are overtopped. Rock aprons are showing wear around a few drop inlets. Some sections of silt fence are down, and need maintained throughout site.**

Where soil is being pushed up against silt fence, there is no holding capacity to allow proper filtration before being overtopped.

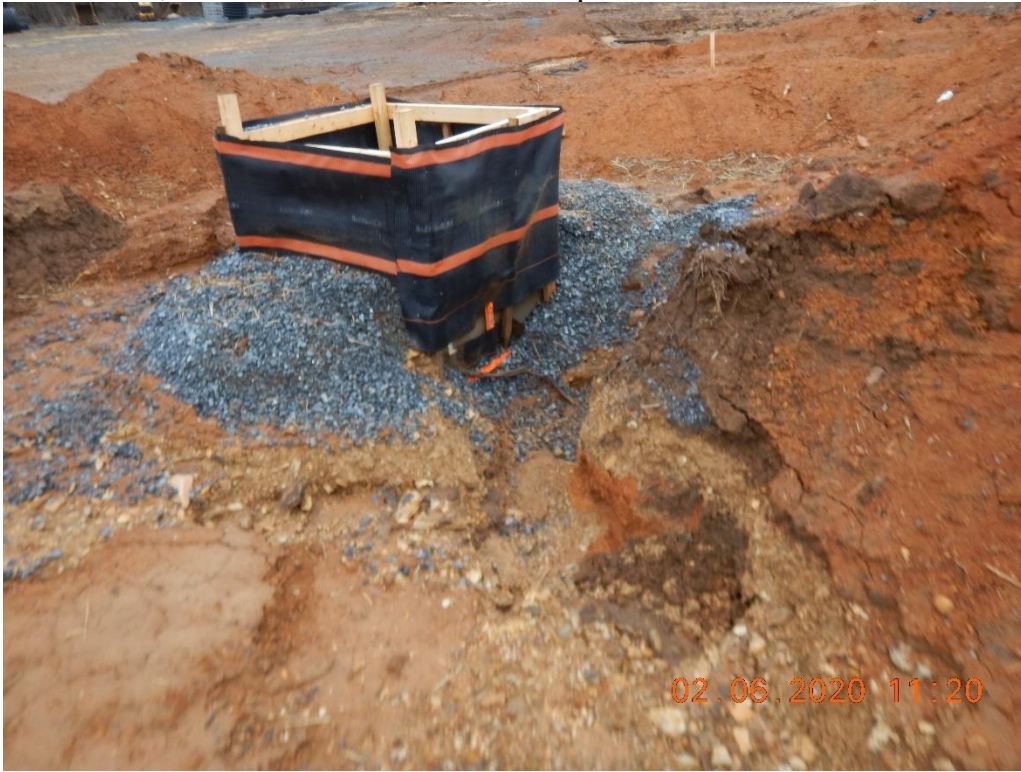
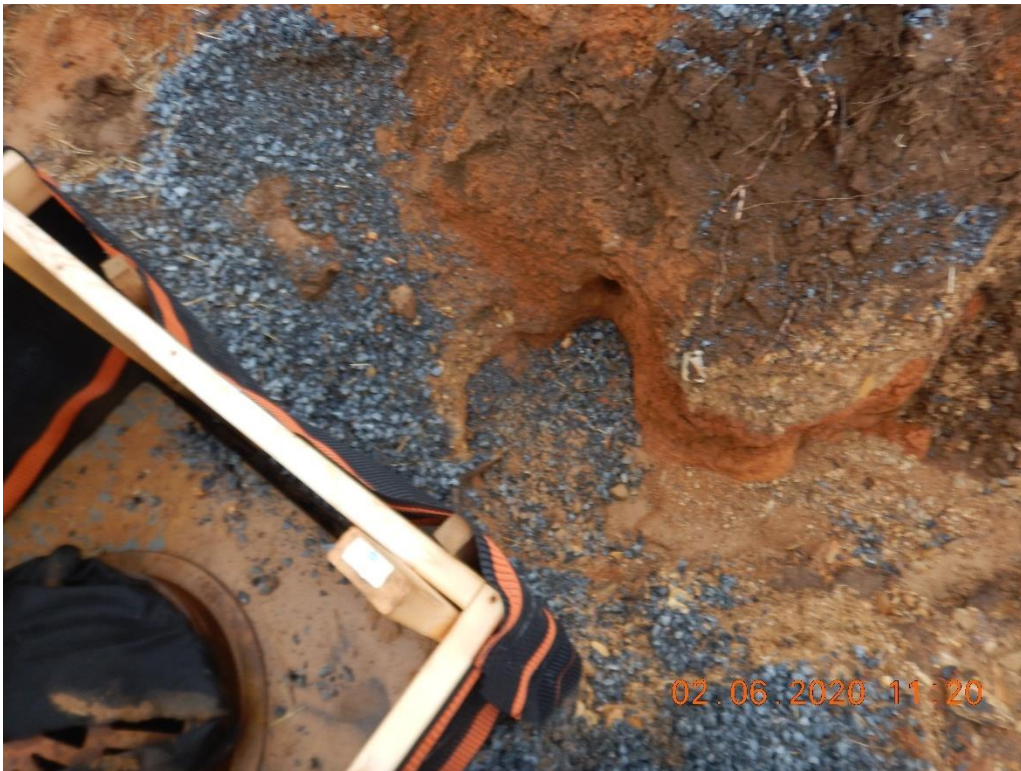
Maintenance on Drop Inlet protection where rock apron has been eroded away.

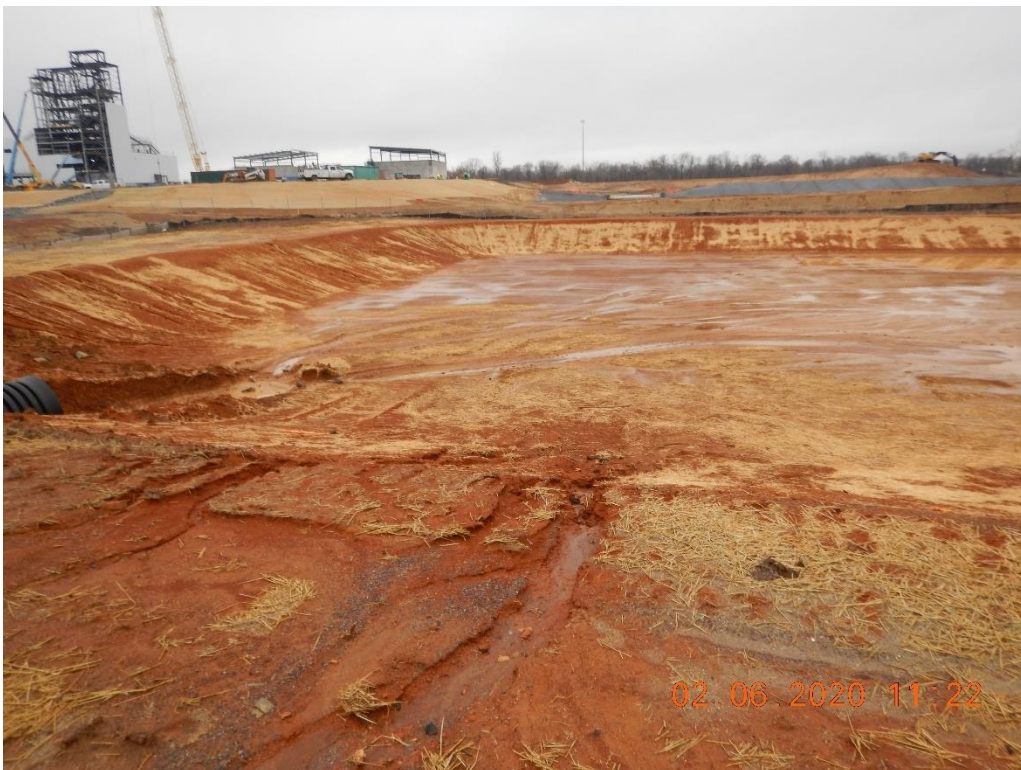
Unprotected inlets into sediment basin from erosion rills.

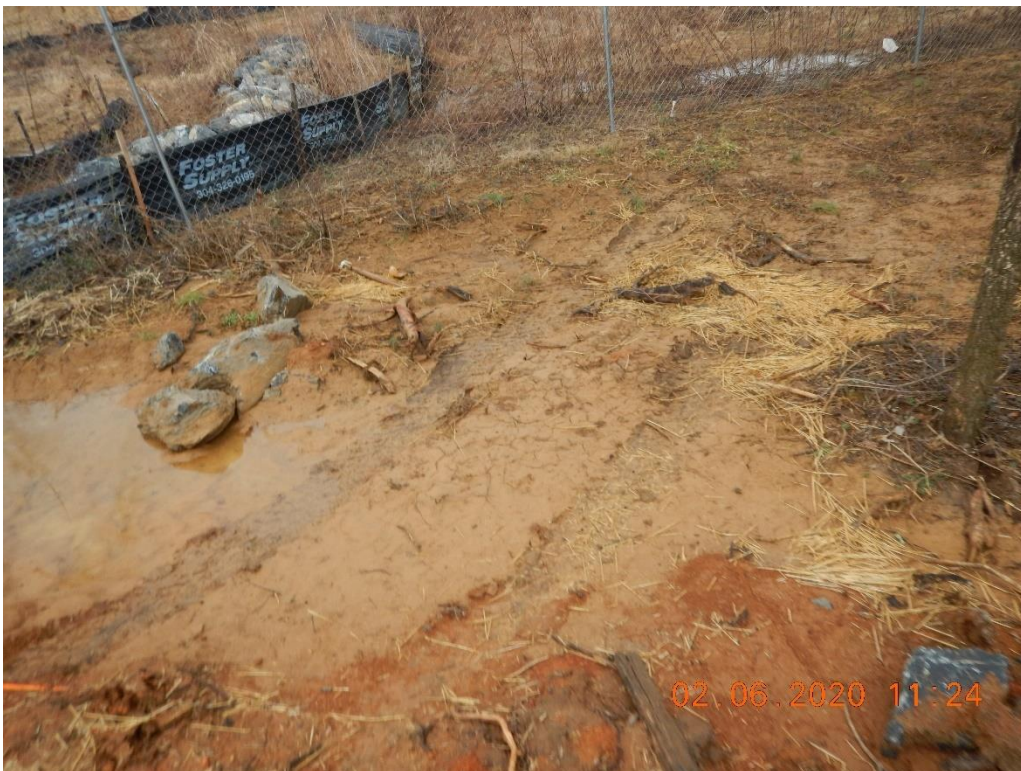
Sediment deposit outside the LOD below Sediment Basin. No perimeter controls installed at this location.

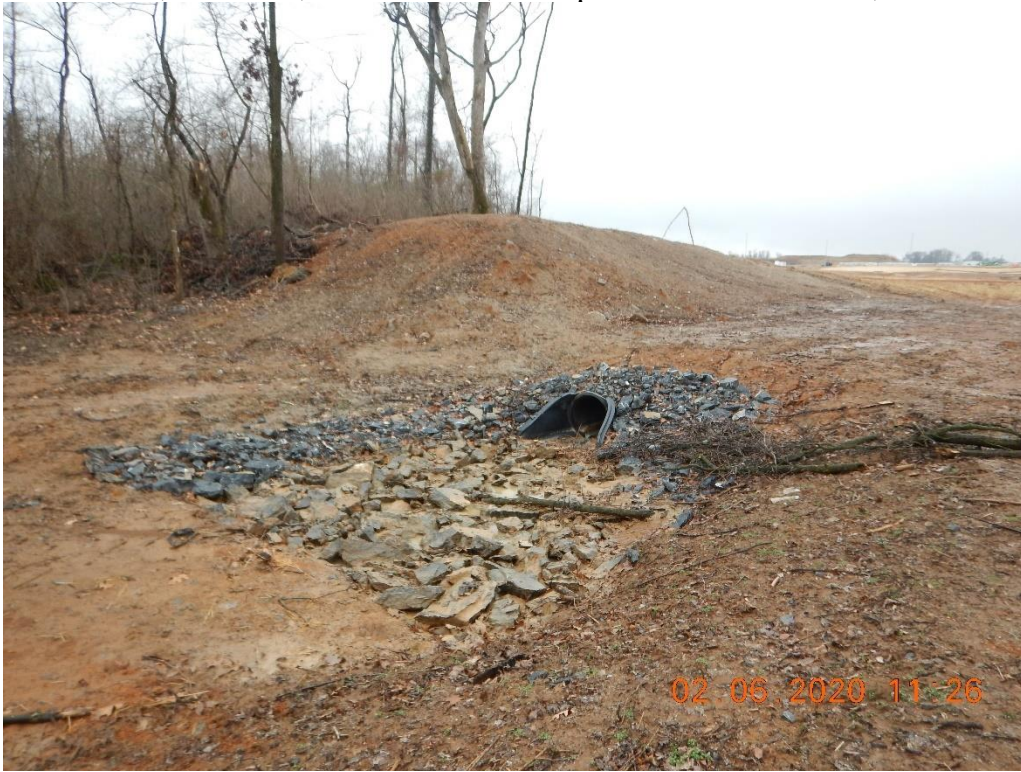
2. **Section C.15.- City of Ranson failed to post an outlet marker at all permitted outlets from the construction site. No outlet signage was posted at the outfall of the sediment basin.**

Outfall of sediment basin with not signage posited. Rip rap apron is stained with sediment from improperly operated basin.

4. Install necessary erosion control devices and modify the SWPPP to prevent sediment- laden water from leaving the site.
5. Display an outlet marker on the stream bank in accordance with Title 47, Series 11, Section 9 of the WV Legislative Rules (Special Rules).

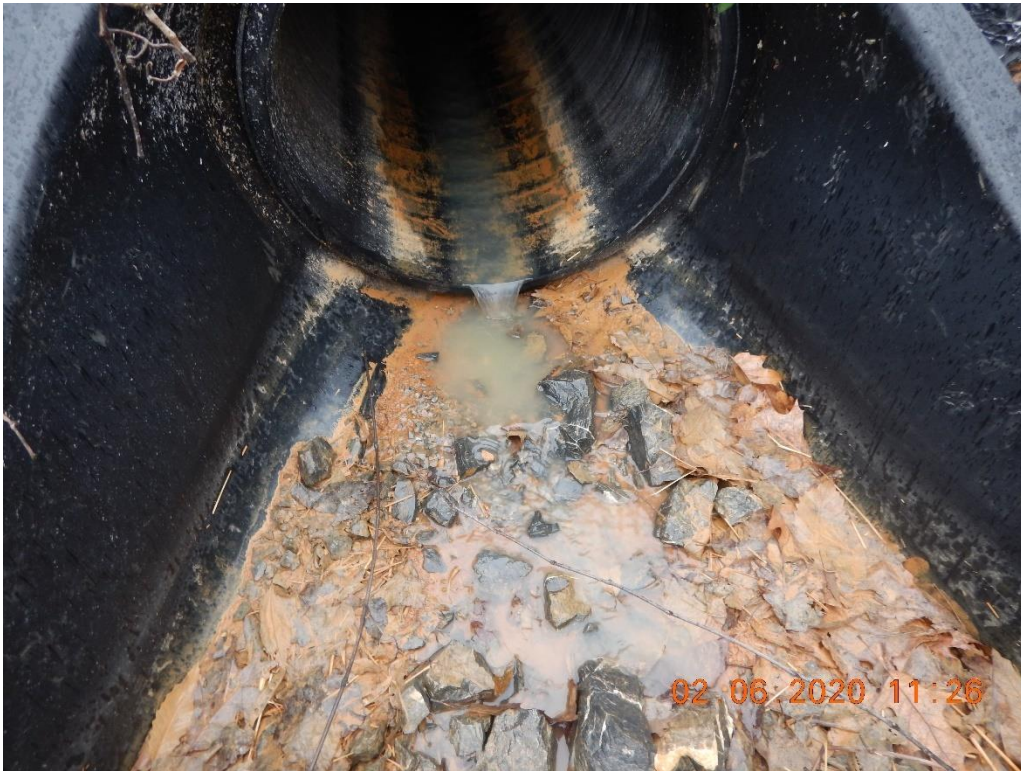
Sediment laden water coming out of sediment basin outfall.

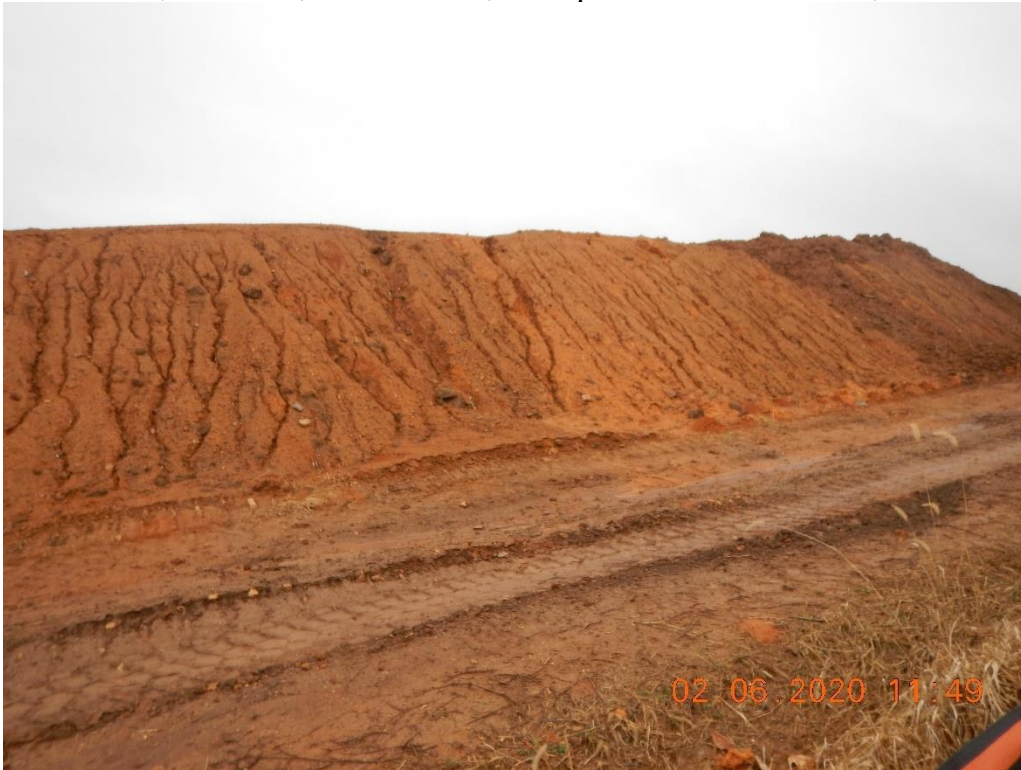
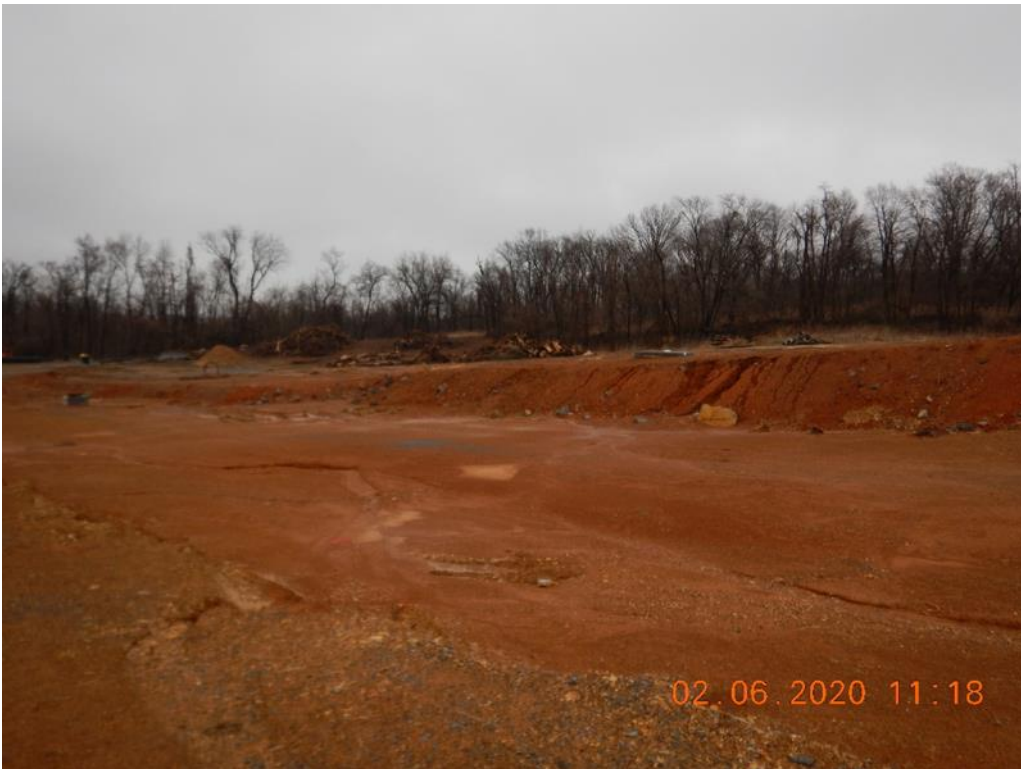
7. Section G.4.e.2.A.i.- City of Ranson failed to provide interim stabilization on areas where construction activities have temporarily ceased for more than 14 days. Soil stockpile and other constructed slopes are not temporary stabilize that have set idle for more than 14 days.

Soil stockpiles are not temporary stabilized with erosion rills.

9. Seed and mulch all areas where construction activities have ceased for more than 14 days.
10. Provide adequate stone at the entrance/exit of the access road.

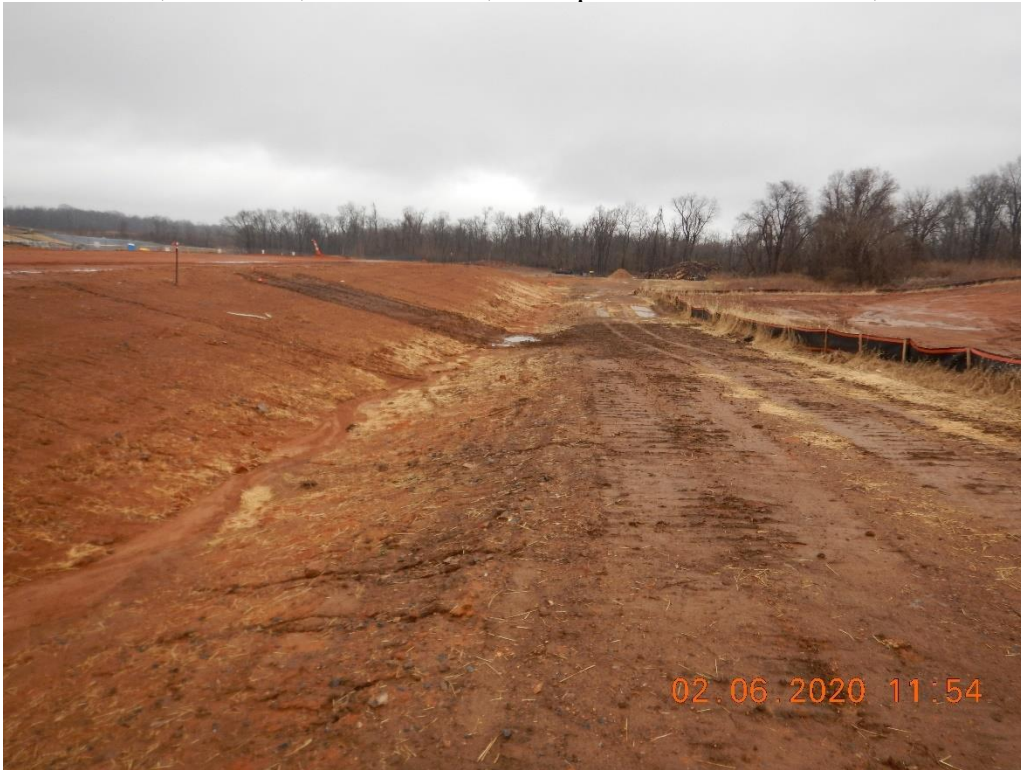
Diversion channel not installed per plan sheet details with ECM and rock check dams.

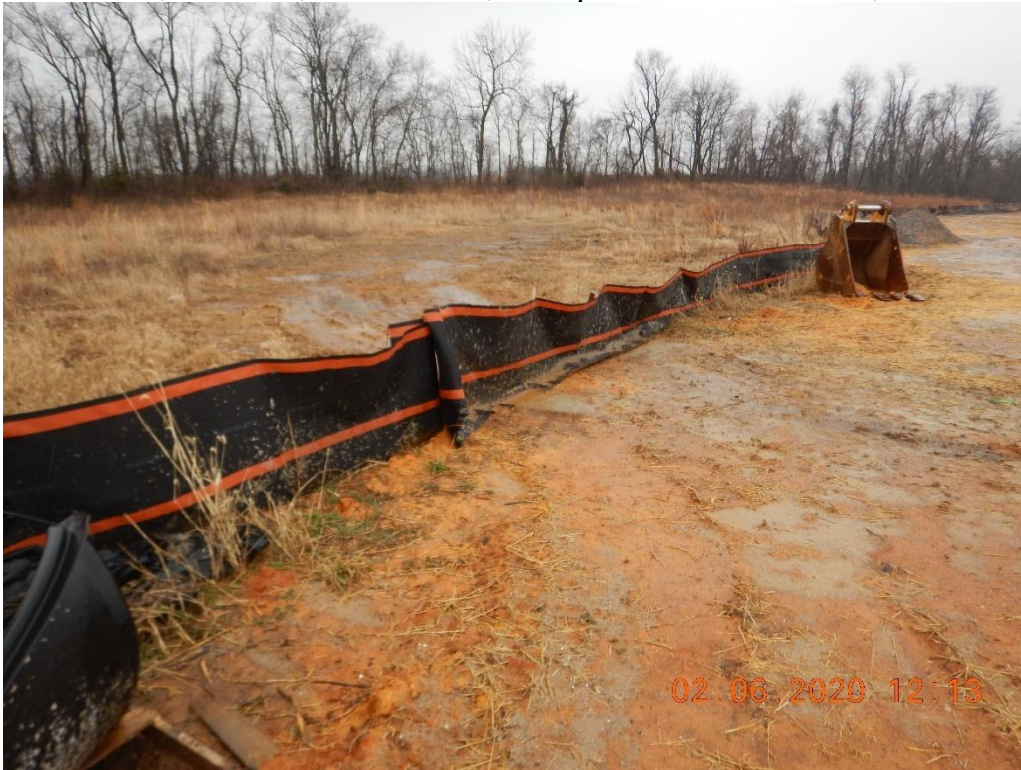
13. Section G.4.e.1.E.: City of Ranson failed to provide an adequate stone access entrance/exit to reduce the tracking of sediment onto the public or private roads. There are multiple construction entrances along the LOD where there are no rock construction entrances. The perimeter controls are just laid in place over the construction entrances.

Multiple construction entrances along LOD of project that are not rocked.

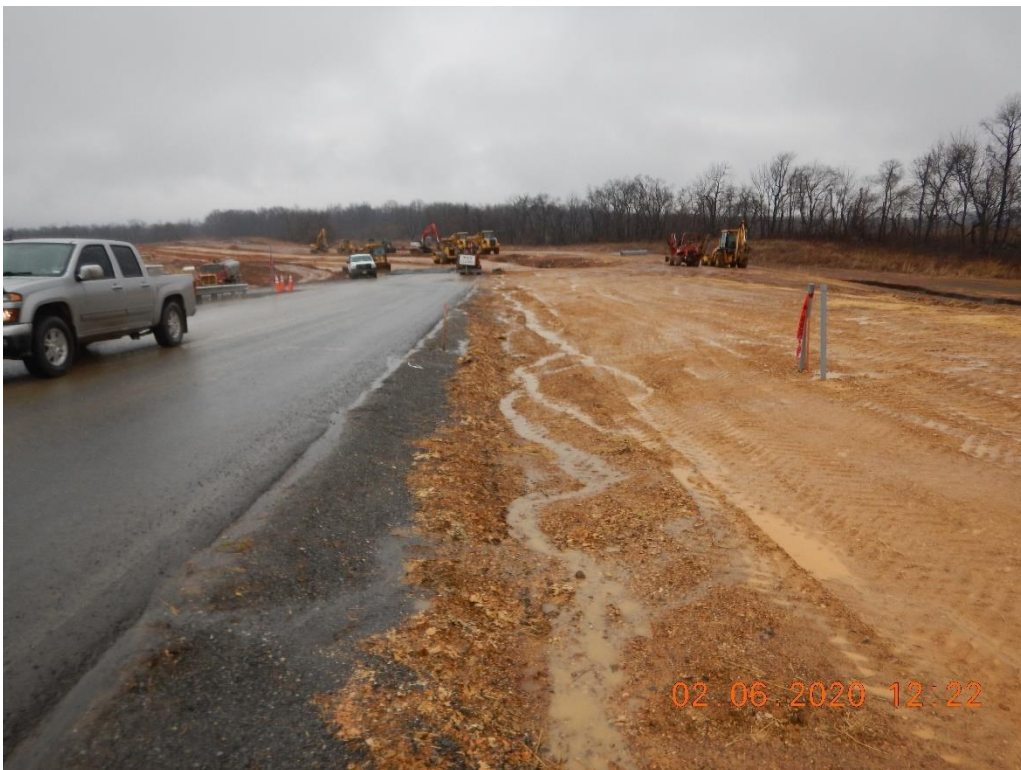
Diversion along Northport Ave. does not have rock check dams as indicated on plan sheet 9.
