**WEST VIRGINIA DEPARTMENT OF ENVIRONMENTAL PROTECTION  
WV/NPDES CONSTRUCTION STORMWATER PERMIT**

<b>FACILITY NAME:</b>	RAN 5 Project		<b>REG. #</b>	<b>EXPIRE DATE:</b>
<b>PERMITTEE</b>	ROXUL USA INC.		WVR108876	2/9/2024
<b>ADDRESS/PHONE:</b>	Attn: KENNETH J. CAMMARATO 4594 CAYCE RD BYHALIA, MS 38611 6628514734			
<b>LOCATION:</b>	Northport		<b>Entry Date/Time:</b>	6/24/2021 11:00am
<b>COUNTY:</b>	Jefferson		<b>Exit Date/Time:</b>	6/24/2021 11:30am
<b>Site Representative /Phone</b>	Stacey Phillips		<b>PHOTOS</b> <input checked="" type="checkbox"/>	
<b>CO-PERMITTEE:</b>			<b>ADDRESS:</b>	
<b>SITE OPERATOR:</b>			<b>ADDRESS:</b>	
<b>PERMITTED ACREAGE</b>	98.79	<b>WEATHER:</b>	Sunny	<b>LAST INSPECTION:</b>
				N/A
<b>RECEIVING STREAM(S)</b>	Rockymarsh Run/Potomac River			<b>NOV: 0</b>
<b>Regular Mail</b> <input checked="" type="checkbox"/>	<b>Certified Mail</b> <input type="checkbox"/>	<b>Tracking #</b>		
<b>OVERALL FACILITY RATING:</b>	Satisfactory	<b>COMPLIANCE OUTCOME</b>	No Violation

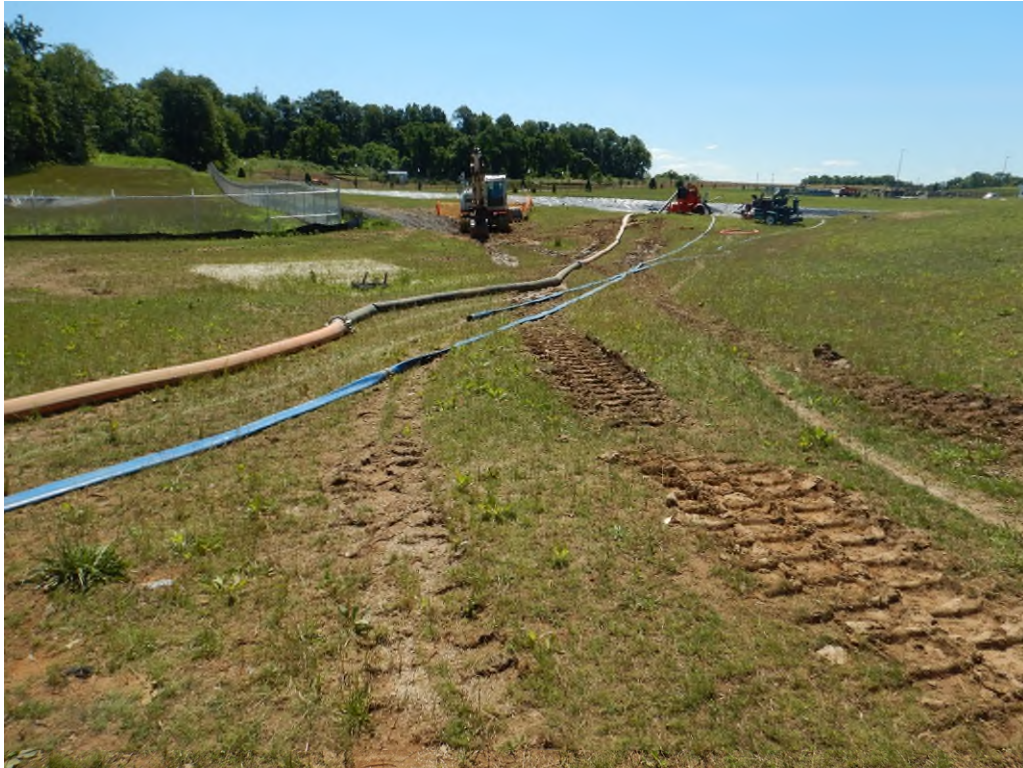
Inspection done per citizen complaint. Found that facility has excavated butterfly discharge valve and is in the process of replacing the faulty valve. Parts have been ordered and the valve is in the process of being replaced. The process pond was being drained into the Stormwater Pond, so the facility could clean up after the resident geese onsite. None of this water is leaving the site. They are in the process of cleaning sediment out of the stormwater pond 1 currently. There has been a turbidity curtain installed in pond 2 just in case any sediment would need to be caught in the construction phase. The RAN5 project is close to completion currently. They have almost reached 70% uniform vegetation over the entire site. No violations have been found at this time.

Work being done on Butterfly Valve for Stormwater Pond

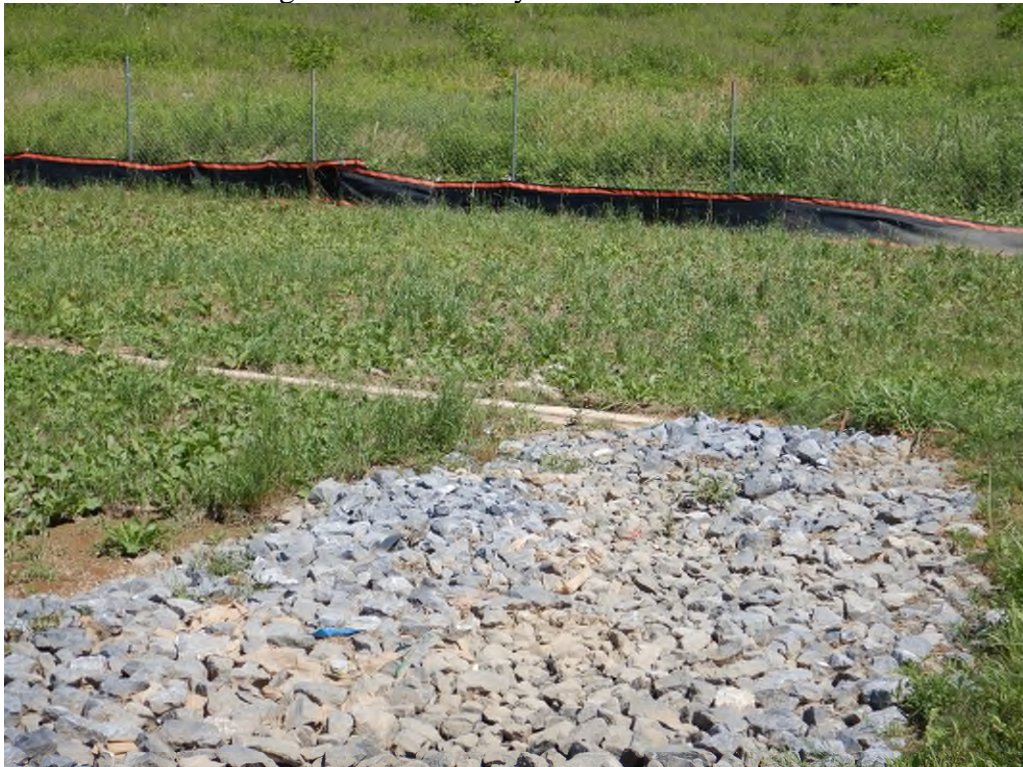
Level Spreader installed per SWPPP.
