# Jefferson County Foundation, Inc.

Re: URGENT Rockwool Stormwater Concerns

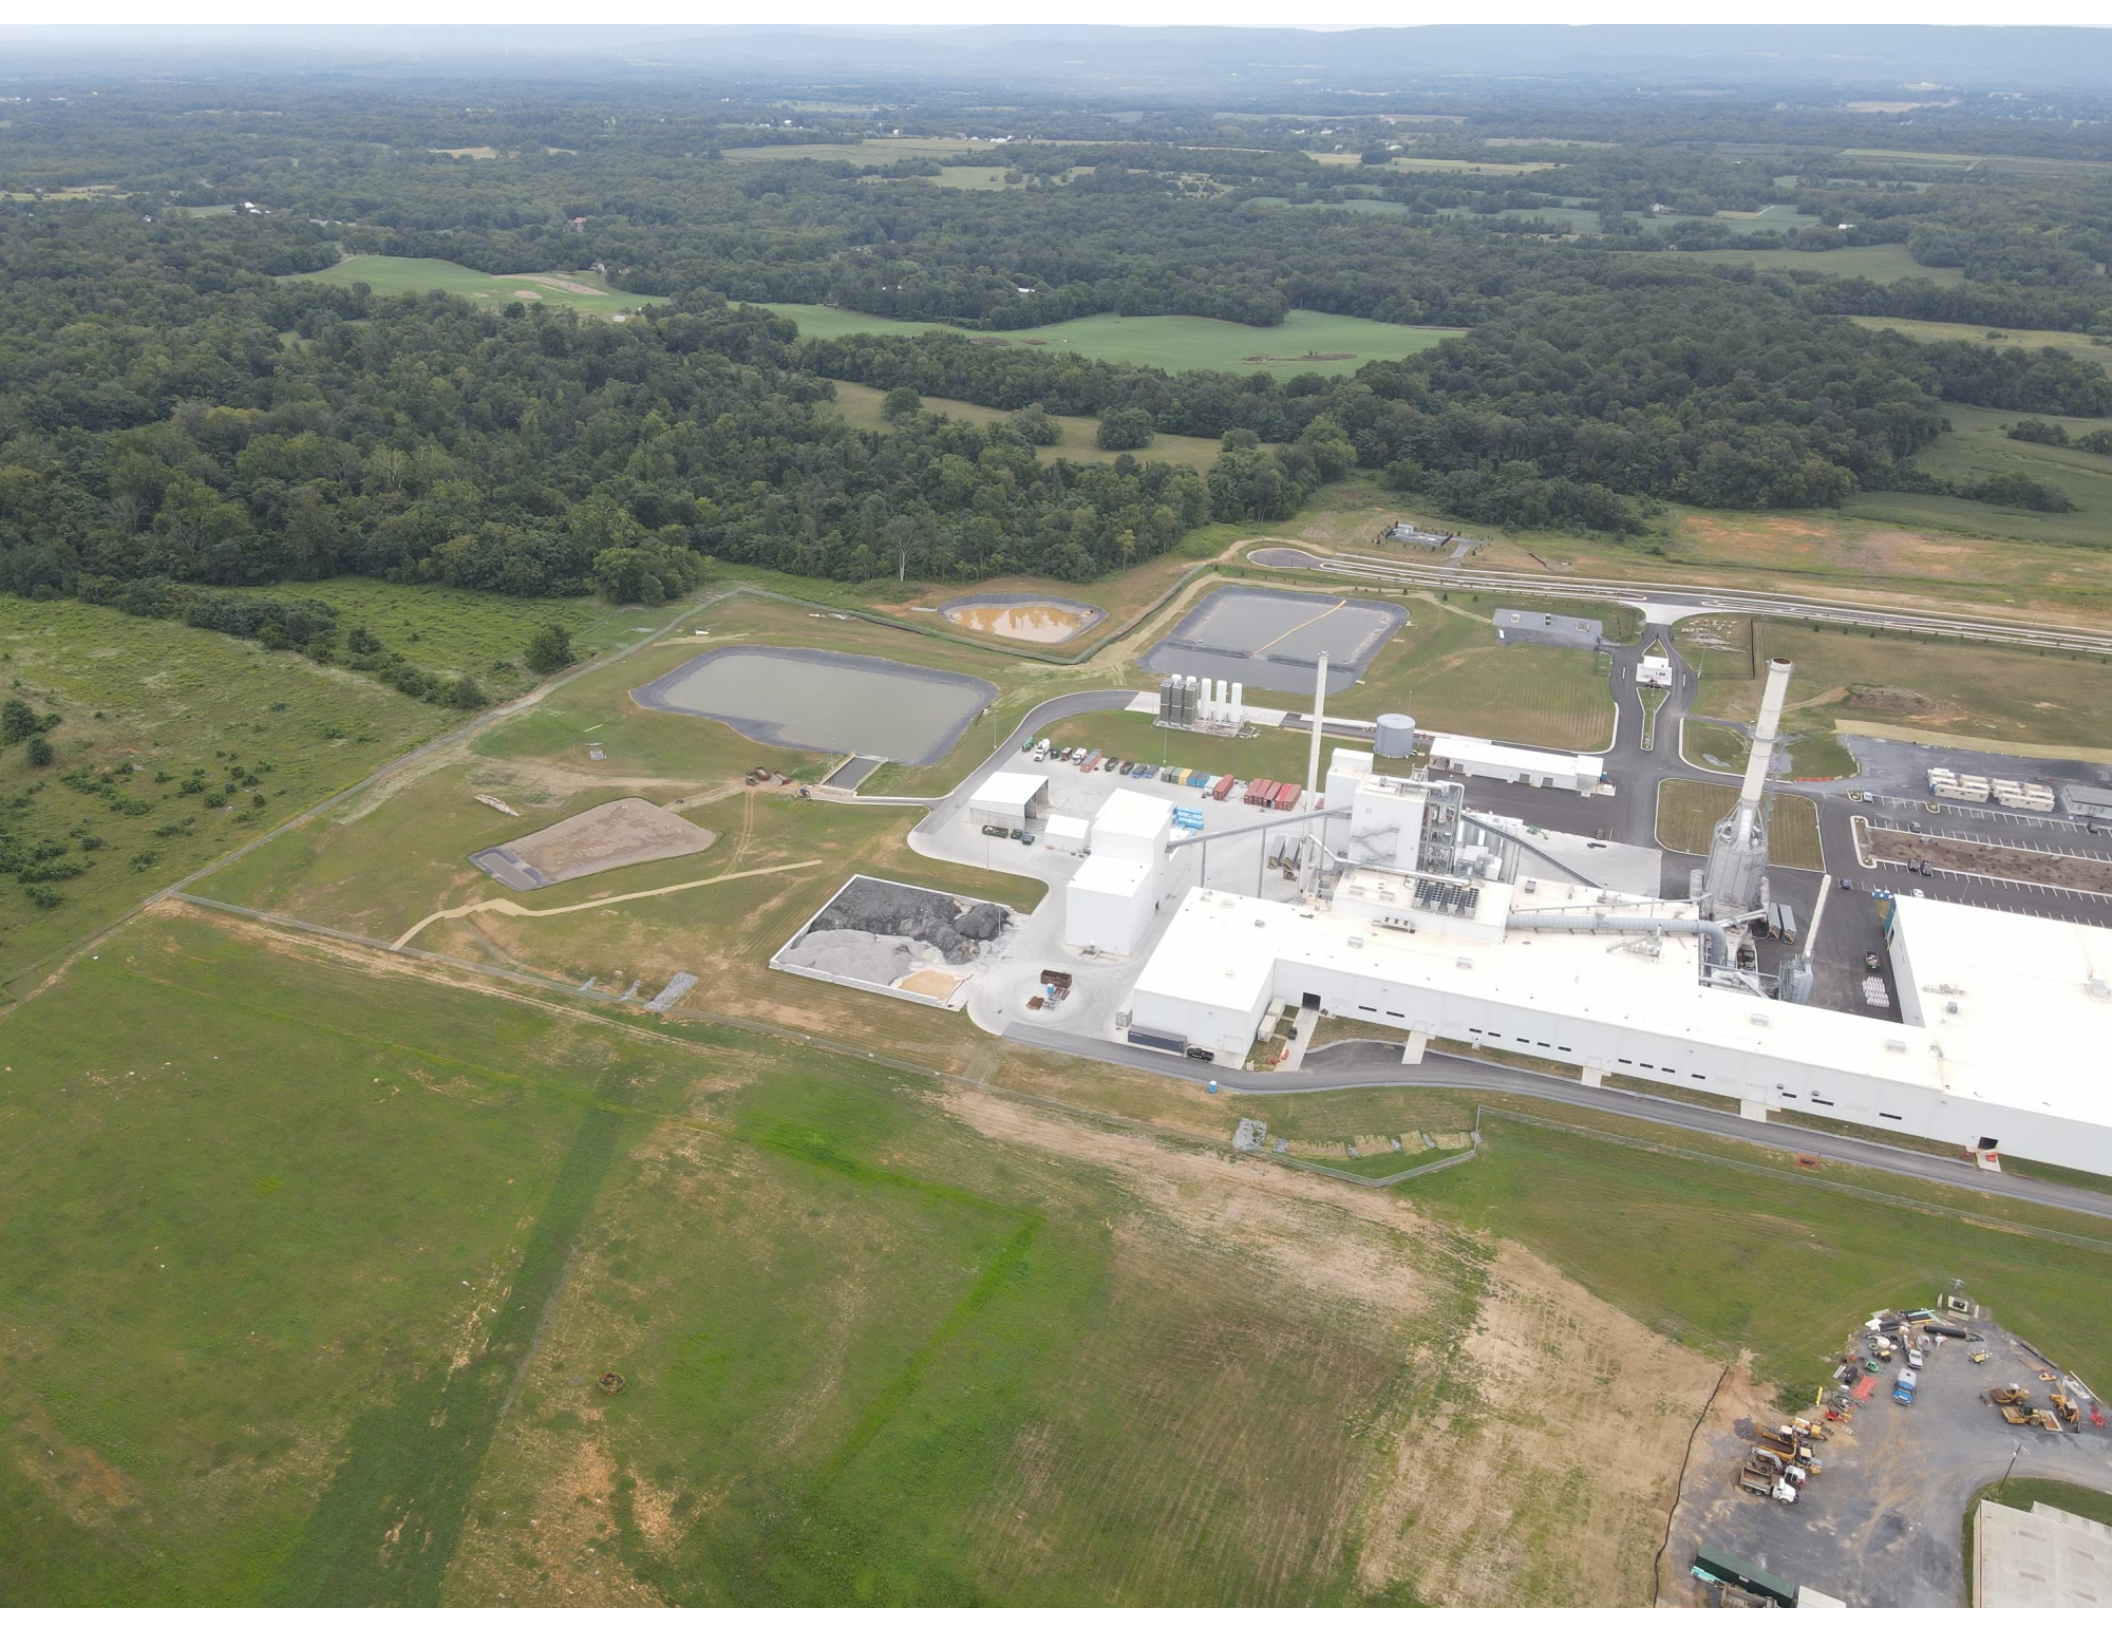
1. Next to the settling pond for the Reuse Pond, there are what appear to be containers with material in them. The settling pond for the Reuse Pond appears to contain liquid (at least in part) and be full. The access road just outside the settling pond seems to be wet while none of the other surfaces appear to be wet (i.e., this does not appear to be from rain as there is

no other evidence of rain). The access road and a large area of the grass area around the containers and the settling pond for the Reuse Pond appear to have sediment on them. What is occurring here? Is the settling pond of the Reuse Pond being cleaned out? If so, is this material on the road and the grass area sediment from the settling pond? Was this being done while the pond is wet or contains liquid?

It appears from this picture that Rockwool has been cleaning out the settling pond while it is still wet, not after it has been dried out, as the permit materials require. It also appears that this material is being collected in containers. Does this mean that there was a “petroleum spill or similar” event? It is alarming that this material has been spilled or tracked across the ground.

2. Vehicle tracks are visible in multiple locations on the site that appear to show prolonged use. Why are vehicles being used in this location? Why are they necessary even though not provided for in the permit? How are materials from the manufacturing areas being prevented from being tracked by these vehicles on to these grass or dirt surfaces and infiltrating into the groundwater?

3. The large northern bioretention area does not seem to be operational in that it has no vegetation. How will this bioretention area achieve best management of the stormwater without vegetation? How will the media be maintained until vegetation is able to grow in this bioretention area? The stormwater outlet for this stormwater structure had well above the reportable limit of heavy metals during the second quarter of 2021.<sup>4</sup> Why is this bioretention area not operational and what is being done to address this situation?

It is imperative for the protection of human health and the environment that the DEP determine what is occurring at the Rockwool site and ensure that Rockwool at a minimum maintains the protections described in the MSGP application and preferably takes every measure necessary to prevent pollution of the groundwater with contaminants from its site.<sup>6</sup> We ask that you take any

and all steps necessary to protect the water resources from Rockwool's activities including investigate the above issues and the as of yet unaddressed issues from the Foundation's previous four letters, and inform the Foundation and the public of your findings. We look forward to the results of the investigation into these issues and resolutions in a timely manner.
