**WEST VIRGINIA DEPARTMENT OF ENVIRONMENTAL PROTECTION  
WV/NPDES CONSTRUCTION STORMWATER PERMIT**

<b>FACILITY NAME:</b>	Northport Avenue Extension			<b>REG. #</b>	<b>EXPIRE DATE:</b>
<b>PERMITTEE</b>	RANSON, CITY OF			WVR110191	9/2/2020
<b>ADDRESS/PHONE:</b>	Attn: ANDREW P. BLAKE, CITY MGR 312 SO MILDRED ST RANSON, WV 25438 3047251010				
<b>LOCATION:</b>	39 22 12.95 N77 52 32.83 W			<b>Entry Date/Time:</b>	2/6/2020 @ 1103
<b>COUNTY:</b>	Jefferson			<b>Exit Date/Time:</b>	2/6/2020 @ 1224
<b>Site Representative /Phone</b>				<b>PHOTOS</b> <input checked="" type="checkbox"/>	
<b>CO-PERMITTEE:</b>				<b>ADDRESS:</b>	
<b>SITE OPERATOR:</b>				<b>ADDRESS:</b>	
<b>PERMITTED ACREAGE</b>	24.4	<b>WEATHER:</b>	Rain	<b>LAST INSPECTION:</b>	N/A
<b>RECEIVING STREAM(S)</b>	Rockymarsh				<b>NOV:</b> <b>W20-19-012-TDH</b>
<b>Regular Mail</b> <input type="checkbox"/> <b>Certified Mail</b> <input checked="" type="checkbox"/>		<b>Tracking #</b> 70192970000166130895			
<b>OVERALL FACILITY RATING:</b>	<b>Unsatisfactory</b>		<b>COMPLIANCE OUTCOME</b>	<b>Not Immediately Corrected</b>

STATE OF WEST VIRGINIA  
Department of Environmental Protection  
Environmental Enforcement  
NOTICE OF VIOLATION

Viol

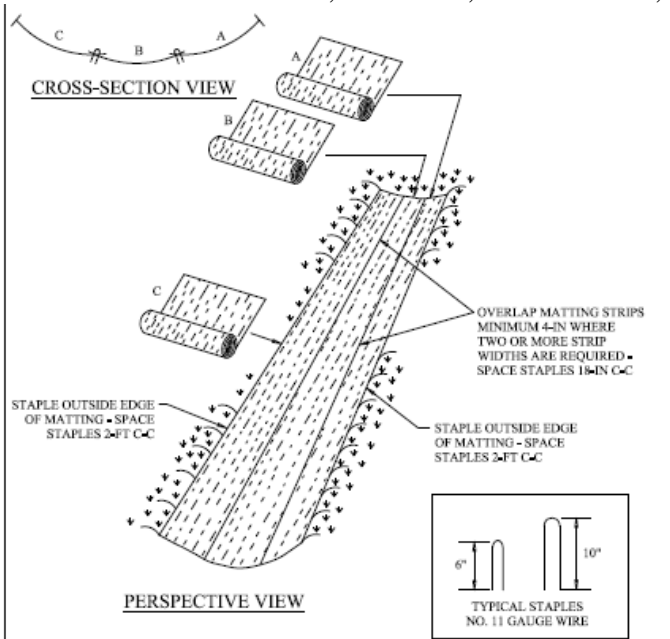
**EROSION CONTROL MATTING DETAIL**  
NOT TO SCALE

7. Section G.4.e.2.A.i.- City of Ranson failed to provide interim stabilization on areas where construction activities have temporarily ceased for more than 14 days. Soil stockpile and other constructed slopes are not temporary stabilize that have set idle for more than 14 days.

Soil stockpiles are not temporary stabilized with erosion rills.

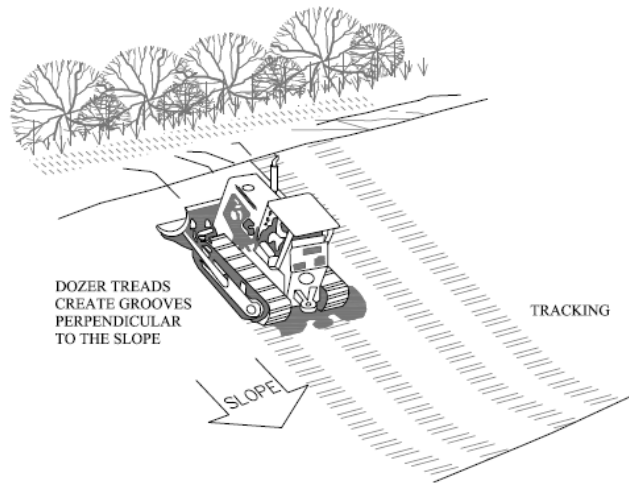
**TRACKING A CONSTRUCTED SLOPE**  
NOT TO SCALE

10. Section G.4.e.2.A.ii.f.- City of Ranson failed to protect fill slopes. Improperly tracked in constructed slopes are aiding to the development of erosion rills that are forming on fill slopes throughout the project site.

Improperly tracked in constructed slopes are aiding in the development of erosion rills to form on fill slopes that are found throughout the project site.
