Additional Comments Concerning Karst Hydrogeology and Potential for Associated
Environmental Risks at the RAN 5 Site, Jefferson County, West Virginia

Chris Groves, PhD, PG
Western Kentucky University
Bowling Green, KY 42101

April 20, 2021

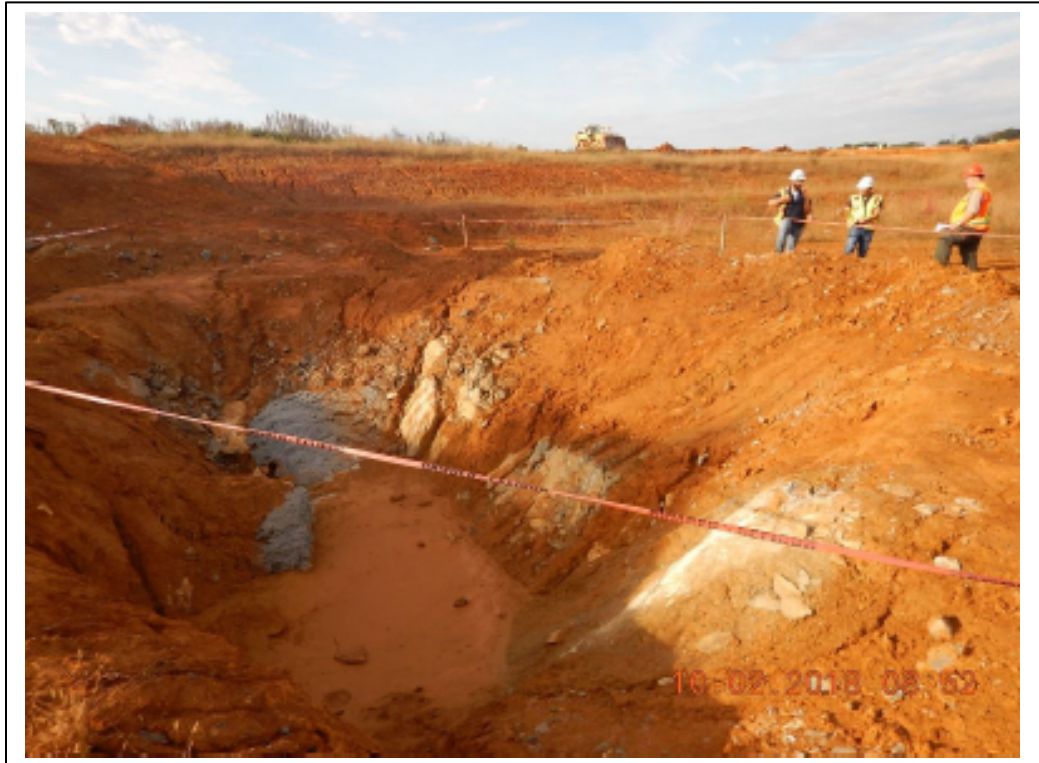
Figure 6. Closed depression or sinkhole in the RAN 5 facility Basin 1 (WVDEP 2018a). All of the rock and soil where the depression is now has moved down through fractures into solutionally-enlarged voids in the bedrock, and aquifer, beneath. This sediment is a contaminant in groundwater (photographer not named).

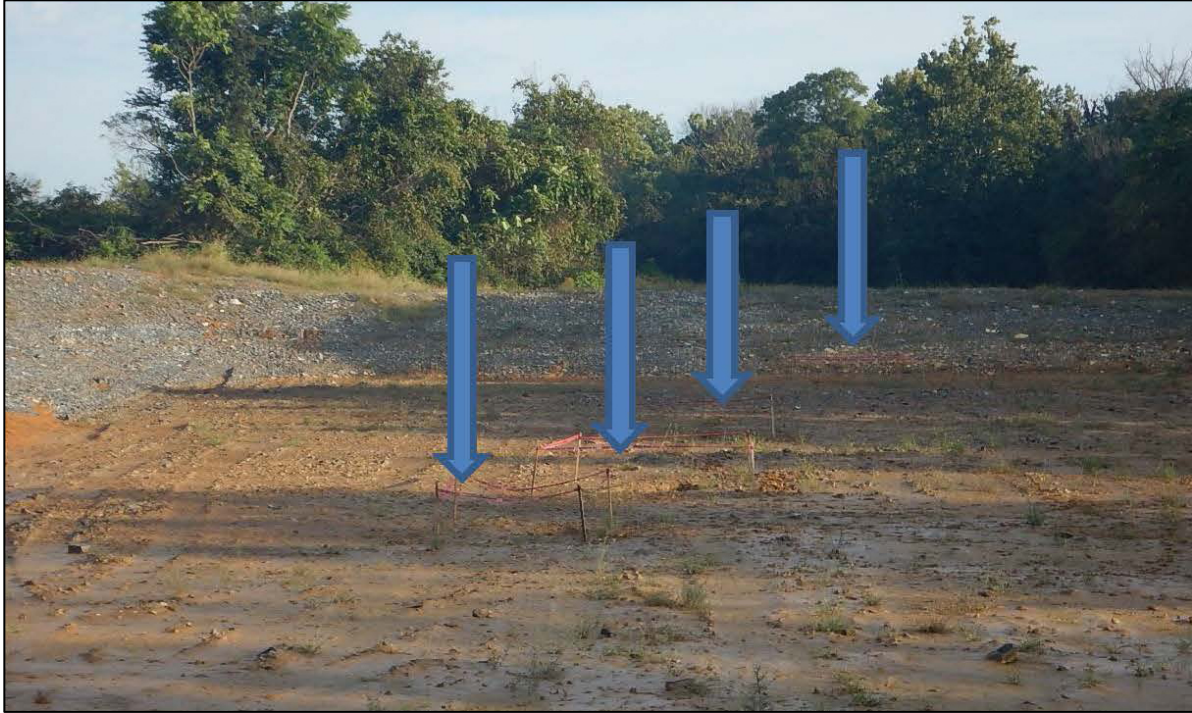
Figure 8. Four sinkholes in the RAN 5 Project Reuse Pond. (WVDEP 2018a) (photographer not named).

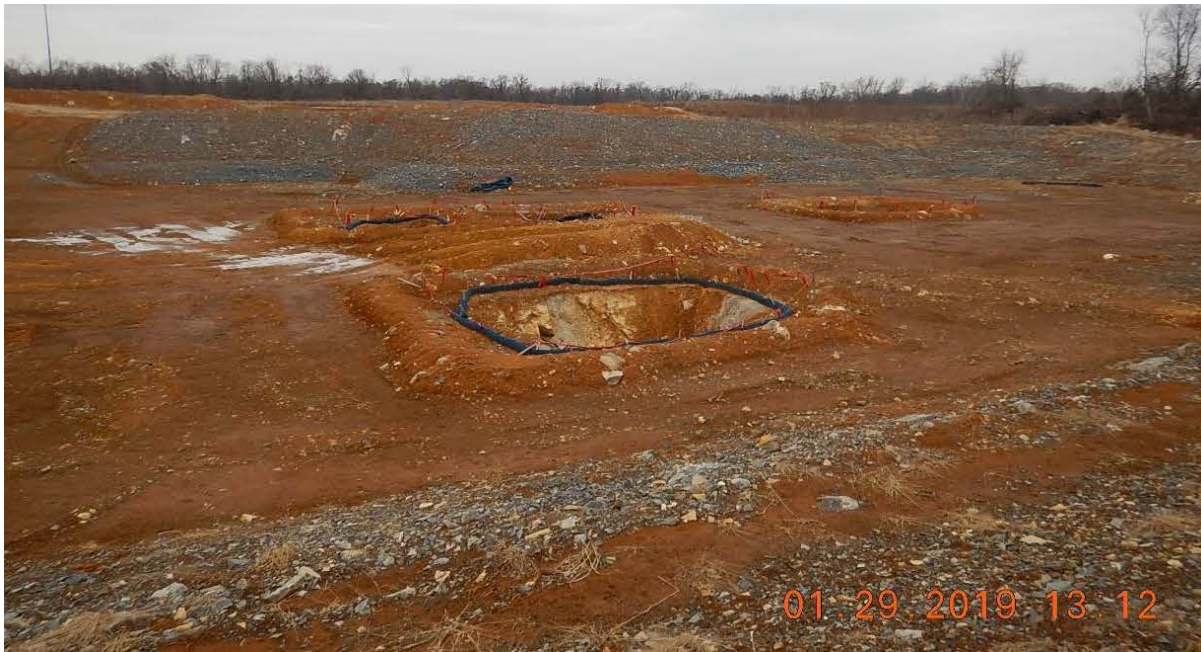
Figure 9. Several sinkholes in the Reuse Pond (WVDEP 2019a) with temporary structures to minimize the transport of sediment into the karst aquifer (photographer not named).

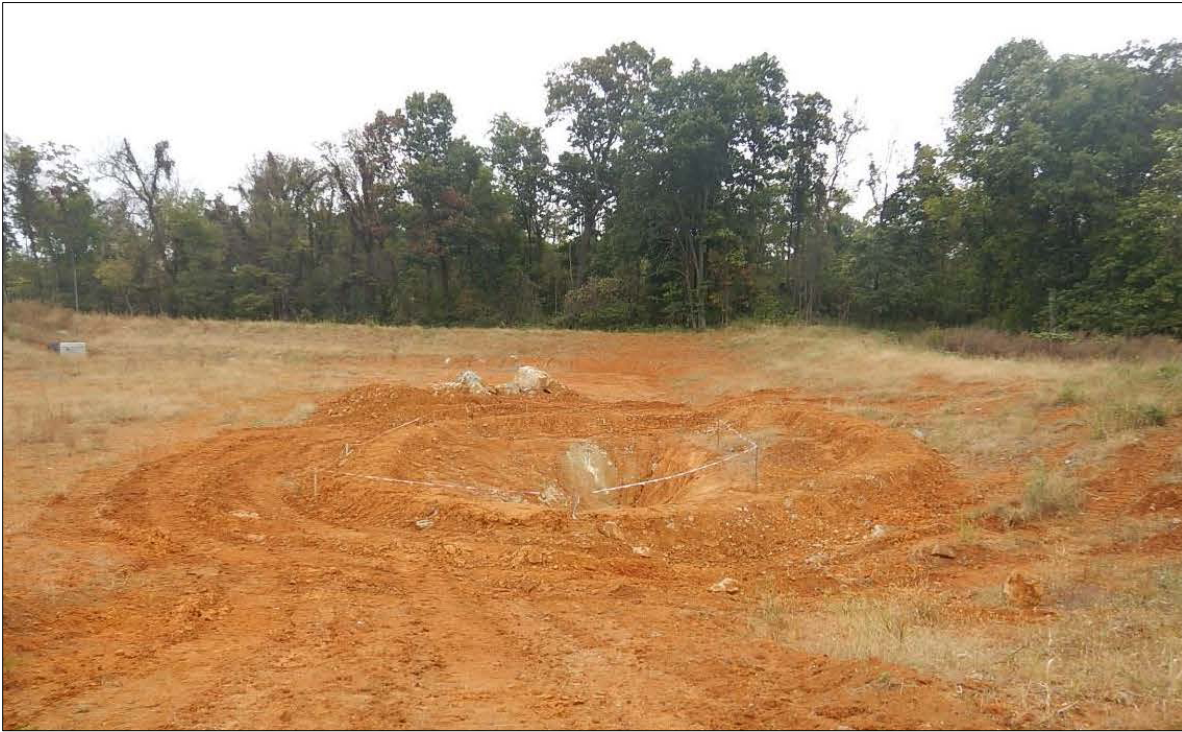
Figure 10. Sinkhole in Sediment Basin #1 (WVDEP 2018d) (photographer not named).

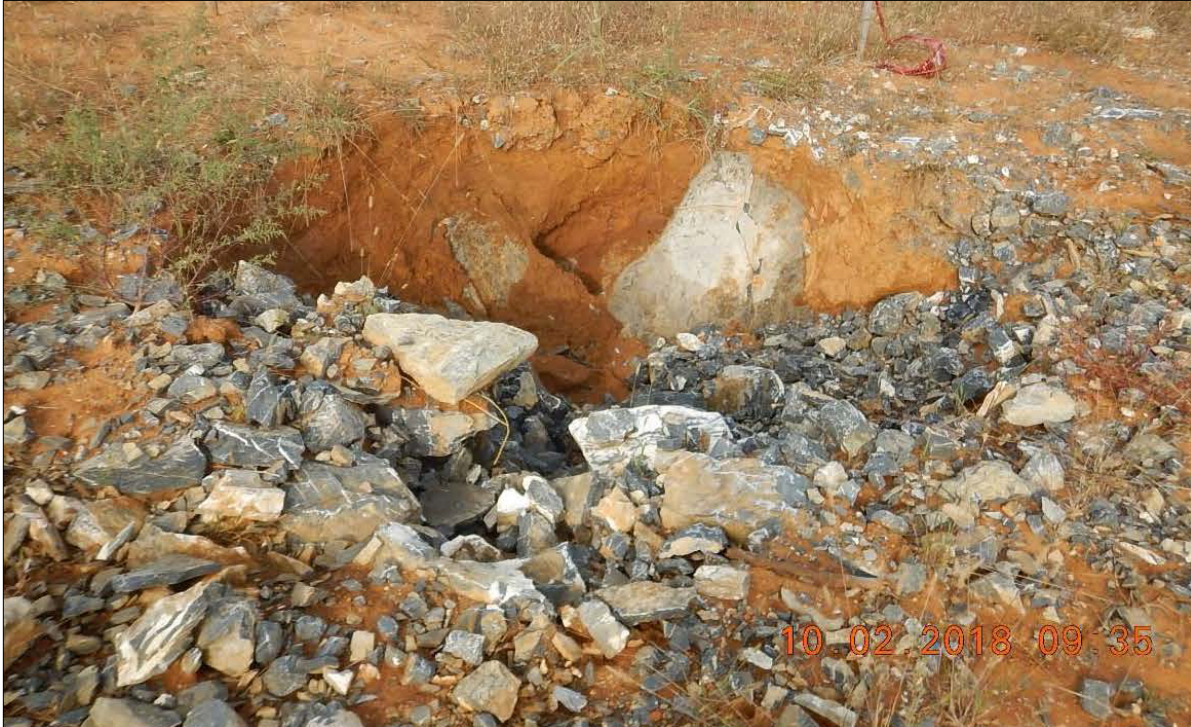
Figure 11. Sinkhole in Sediment Basin #2 (WVDEP 2018a) (photographer not named).
