**Re: Professional Engineering Opinions
Roxul RAN-5 Facility
WV/NPDES Multi-Sector Stormwater General Permit
Ranson, Jefferson County, West Virginia
Langan Project Number: 270112301**

This report focuses on a review of the stormwater design and permitting processes associated with Roxul’s RAN-5 mineral wool manufacturing facility in Ranson, West Virginia. Additionally, this report also provides my professional opinions regarding the adequacy of Roxul’s permit application materials and the WV DEP’s review processes.

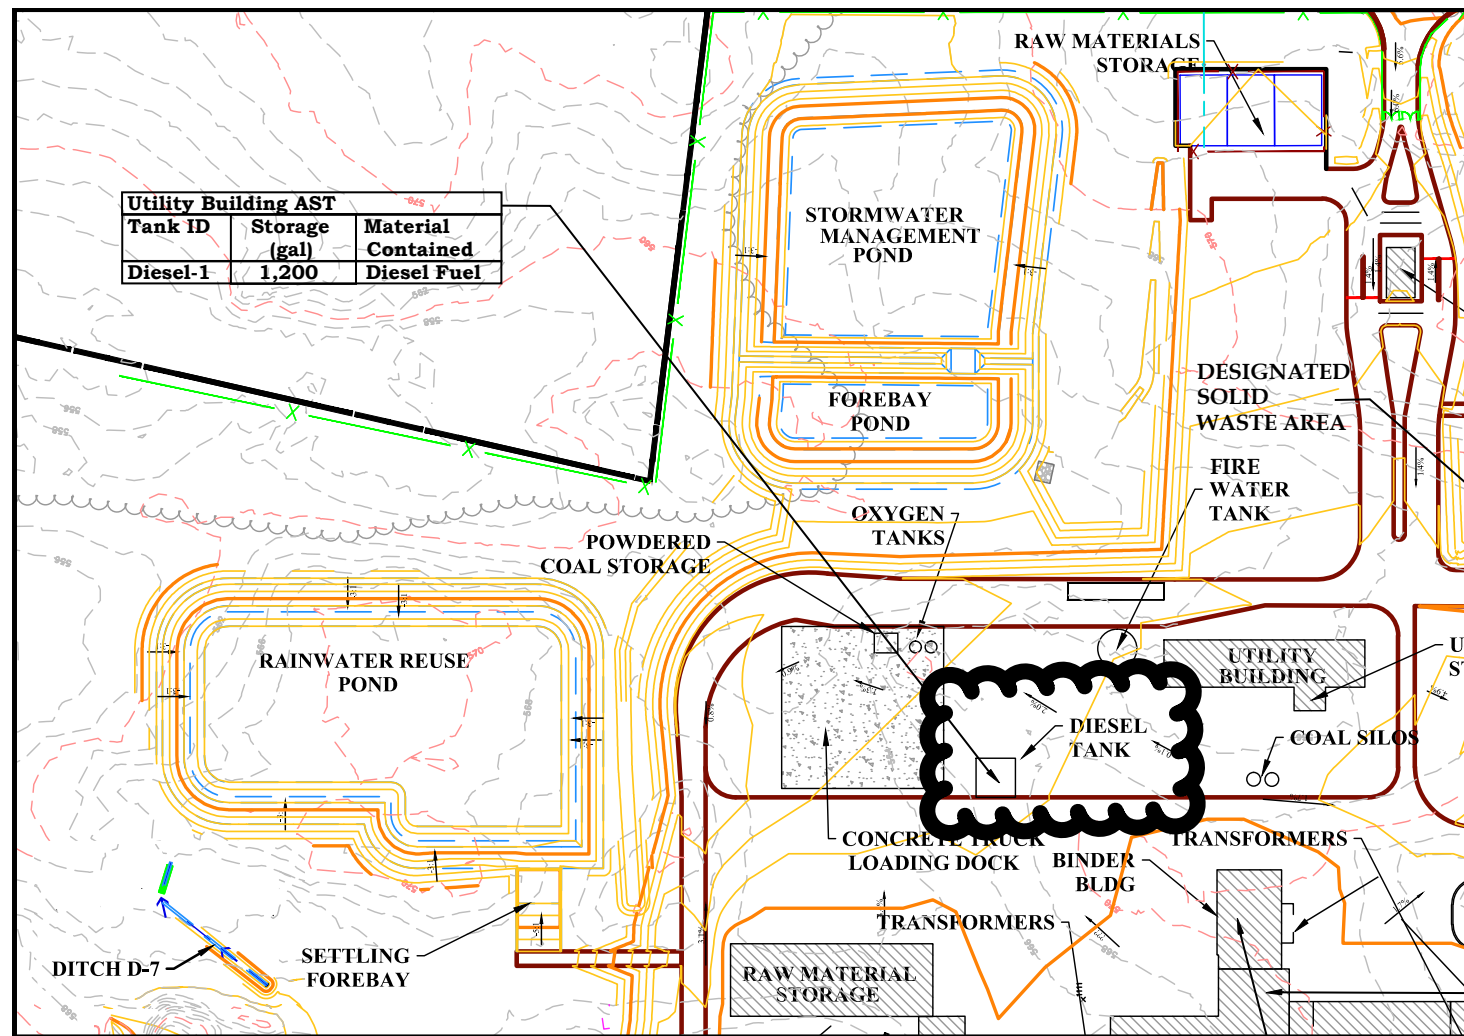
Inset from The SWPPP Figure 2B

Proposed major contour highlighted on all insets for clarity.
