STATE OF WEST VIRGINIA
DEPARTMENT OF ENVIRONMENTAL PROTECTION
ENVIRONMENTAL ENFORCEMENT
INDUSTRIAL STORMWATER FACILITY INSPECTION REPORT

Facility Name: Rockwool USA, Inc. RAN-5 Facility		Permit /Reg. #: WV0111457 WVG611896	Expiration Date: 9/12/24
Permittee: Roxul USA Inc.			
Site Representative /Title: Ken Cammarato VP, General Counsel			
Location: Kearneysville		Entry Date / Time: 9/1/21 11:45am	
County: Jefferson		Exit Date / Time: 9/1/21 1pm	
Address /Phone: 665 Northport Avenue Kearneysville, WV 25430	Regular Mail: <input type="checkbox"/> Certified Mail: <input type="checkbox"/>		Photos: <input checked="" type="checkbox"/>
	Tracking # 7019 1120 0001 6932 5775		
		Samples: <input type="checkbox"/>

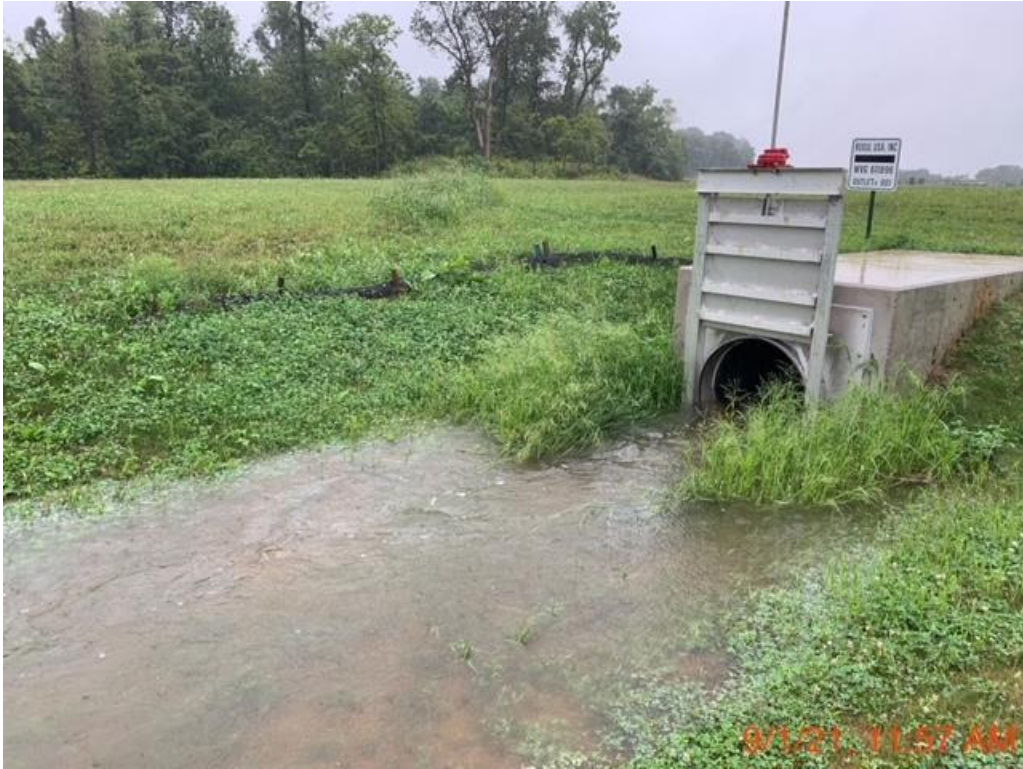
Outlet 001

Outlet Number	001	002									
Appearance	S	Cloudy									
Marker	S	S									
Receiving Stream	N/O	N/O

The valve from the forebay pond to outlet 001 has been repaired.

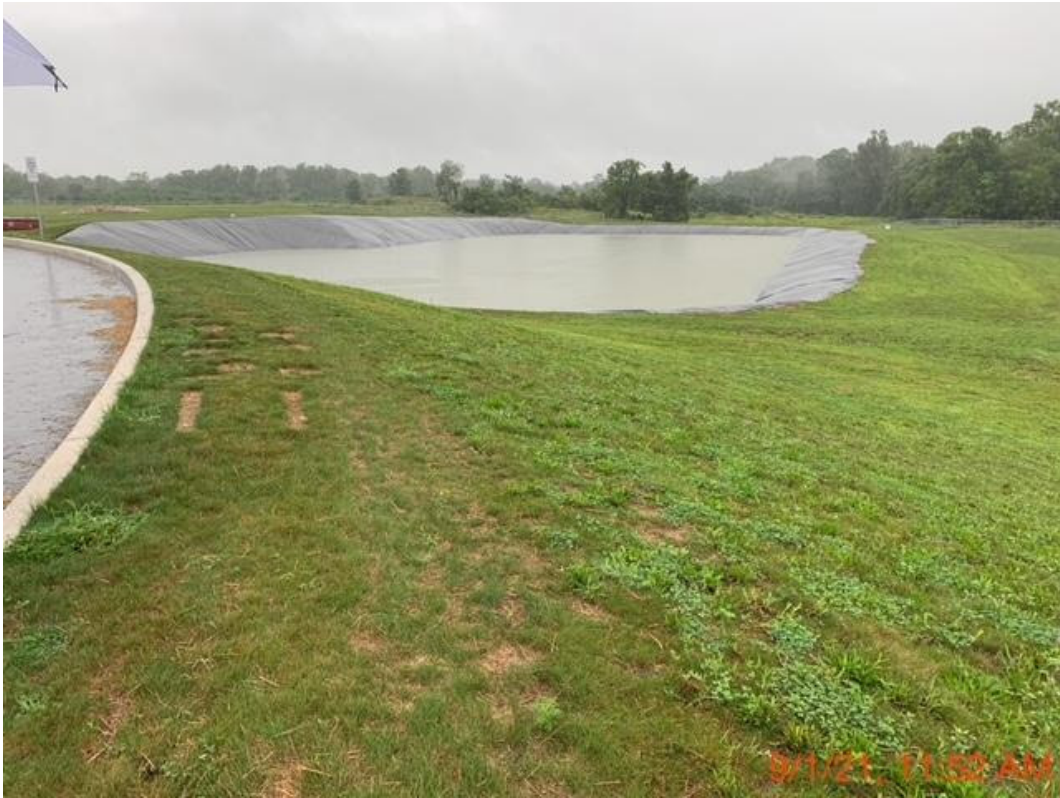
Rainwater Collection Basin (Reuse Pond)

Rockwool has been cleaning the Rainwater Collection Basin (Formerly called the Reuse Pond). The sediment that had accumulated in the weir was pumped into settling tanks and the water is returned back to the rainwater collection basin through a filter bag. The sediment in the filter bags are disposed by Clean Harbors located in Baltimore, Maryland. The only vehicle tracks observed during the inspection inside the fenced area around the plant were to the bio-retention pond. The work to the bio-retention pond, which discharges to outlet 002, has not been completed due to weather conditions at the facility. Turbid water was exiting Outlet 002, but this outlet does not discharge directly into a stream. The water flows over several hundred feet of vegetation before leaving the Rockwool property on the north side and continues over the Jefferson County Development's property. WVDEP inspectors have not inspected the liner system, however the system was inspected before and after the repair by a licensed professional engineer. WVDEP is awaiting the report on that inspection from Rockwool.
